Yreka Carnegie Library

Historic Structure Report - DRAFT

Prepared by:
GPA Consulting
617 S. Olive Street
Suite 910
Los Angeles, CA 90014

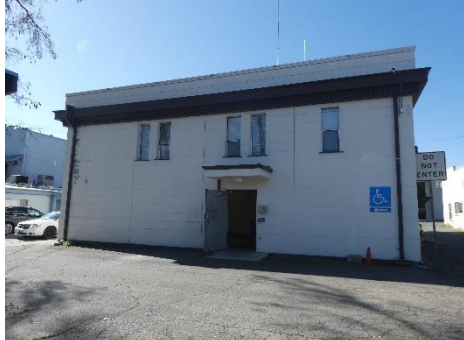
Not Character-Defining: <ul style="list-style-type: none"> • Postdates period of significance 	N/A. Project team noted cracking in masonry and water damage to cornice line.

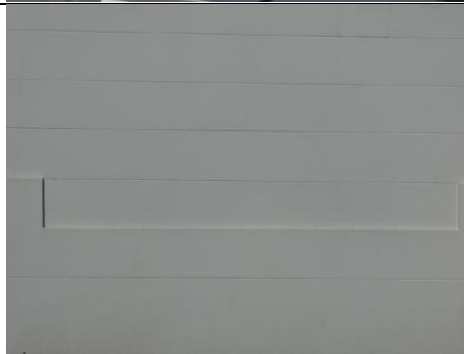
Primary: <ul style="list-style-type: none"> Original Highly visible Minimally altered since the end of the period of significance 	Fair to Good. Minor cracking and chipping observed. No alterations observed.

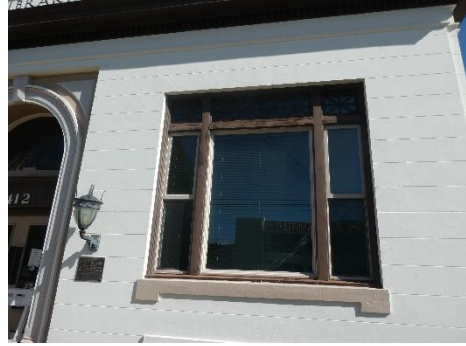
<p>Primary:</p> <ul style="list-style-type: none"> • Original • Highly visible • Minimally altered since the end of the period of significance 	<p>Fair. Wood transom and muntins showing signs of deterioration, likely caused by excess moisture.</p> <p>Double-hung wood sashes appear to have been replaced in-kind at an unknown date.</p>

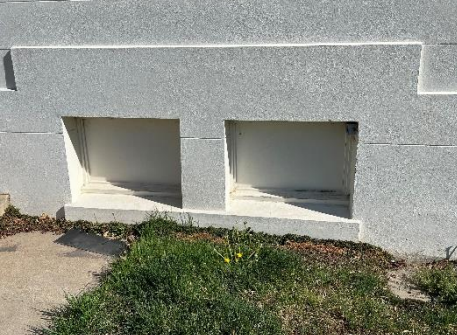
<p>Secondary:</p> <ul style="list-style-type: none"> • Original • Partially visible • Utilitarian in design/function • Altered since the end of the period of significance 	<p>Fair.</p> <p>Glazing has been painted at an unknown date.</p>

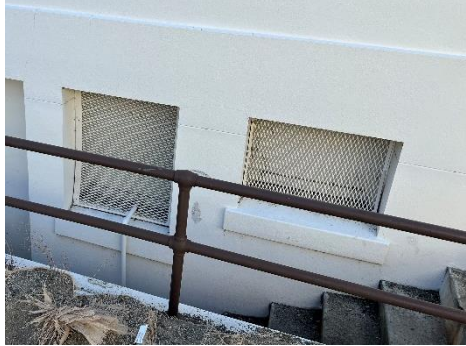
Not Character-Defining: <ul style="list-style-type: none"> • Less visible • Utilitarian in design/function • Altered since the end of the period of significance 	Fair. Glazing has been painted at an unknown date, metal security mesh installed over exterior of window openings at unknown date.
Cast Concrete <ul style="list-style-type: none"> • South, east, and west elevations of original building • Painted • Library Sign • Main entrance surround • Projecting window sills

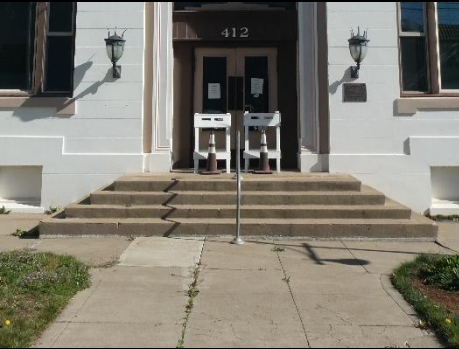
Secondary: <ul style="list-style-type: none"> • Original • Highly visible • Common material 	Fair to Good. Cracking and chipping observed, especially at edges of steps. No major alterations observed.
Centralized Walkway <ul style="list-style-type: none"> • South elevation • Concrete

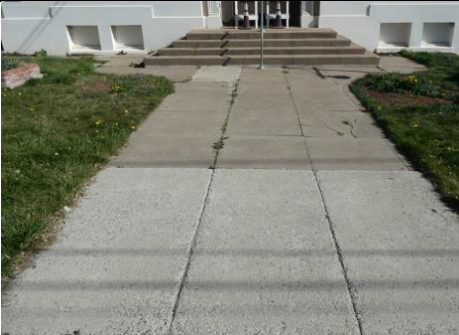
Secondary: <ul style="list-style-type: none"> • Original • Highly visible • Common material • Partially replaced since the end of the period of significance 	Fair to Good. Cracking and chipping observed. Walkway partially replaced with concrete of a different appearance/texture.

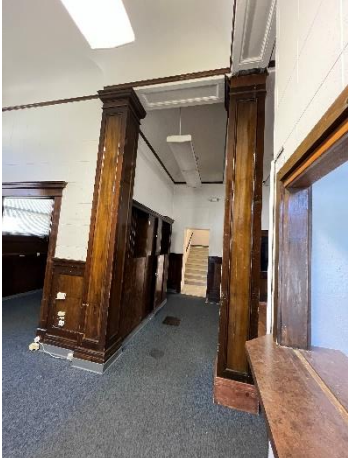
<p>Primary:</p> <ul style="list-style-type: none"> • Original • Highly visible • Minimally altered since the end of the period of significance 	<p>Fair to Good. Scratches, gouges, and other signs of wear-and-tear observed.</p> <p>No major alterations observed.</p>

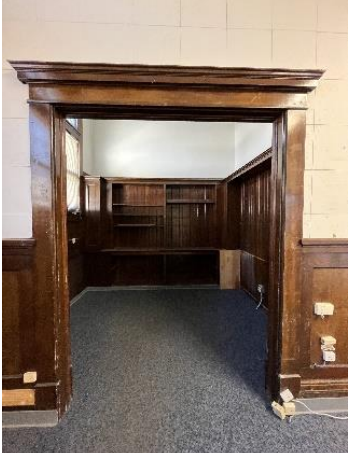
<p>Primary:</p> <ul style="list-style-type: none"> • Original • Highly visible • Minimally altered since the end of the period of significance 	<p>Fair to Good. Scratches, gouges, and other signs of wear-and-tear observed.</p> <p>No major alterations observed.</p>
<p>Built-In Cabinets</p> <ul style="list-style-type: none"> • Open-Space Area • Stained wood • Decorative header • Partial-height cabinet doors

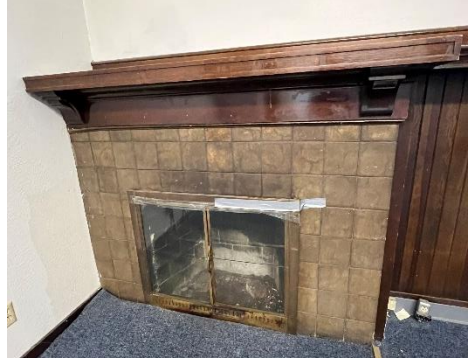
<p>Primary:</p> <ul style="list-style-type: none"> • Original • Highly visible • Minimally altered since the end of the period of significance 	<p>Fair to Good. White paint has been dripped onto the wood and tile. Fire-screen was secured with tape at the time of survey.</p> <p>Fire screen appears to be non-original.</p>
