Environmental Review for Activity/Project that is Categorically Excluded Subject to Section 58.5 Pursuant to 24 CFR 58.35(a)

Project Name: Yreka Carnegie Library Rehabilitation

PHASE I ENVIRONMENTAL SITE ASSESSMENT REPORT

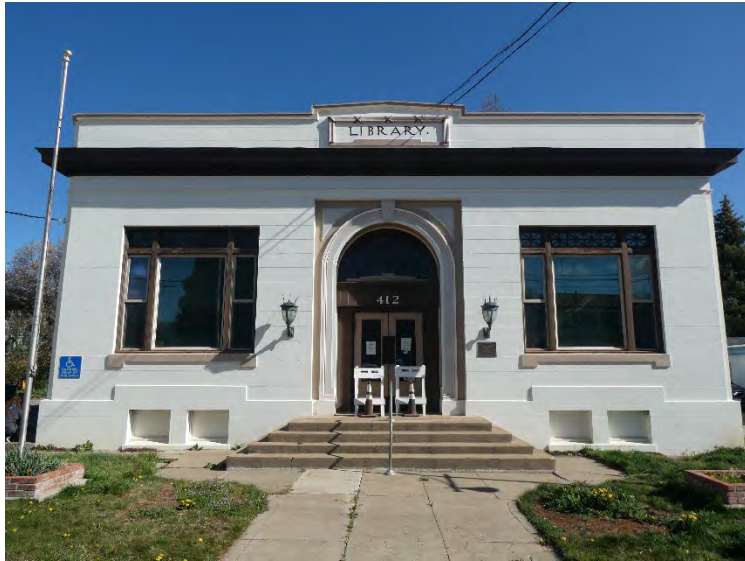
a) South (Front) Elevation

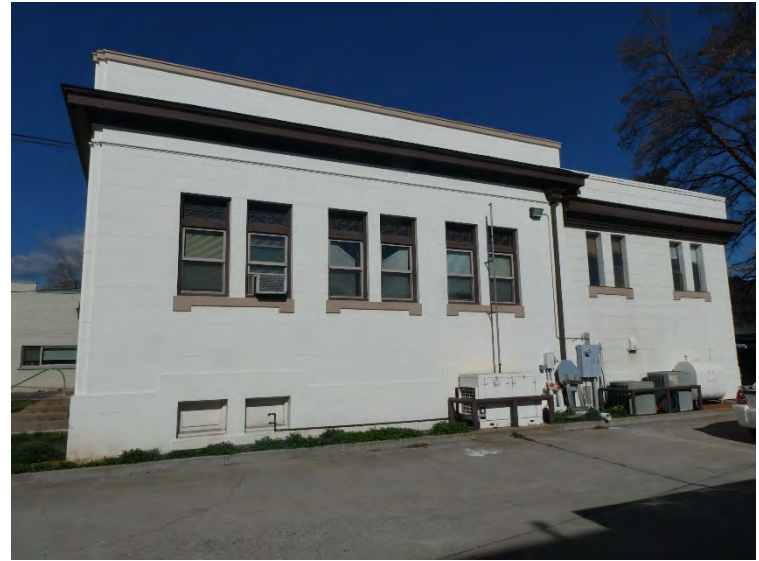
b) East Elevation

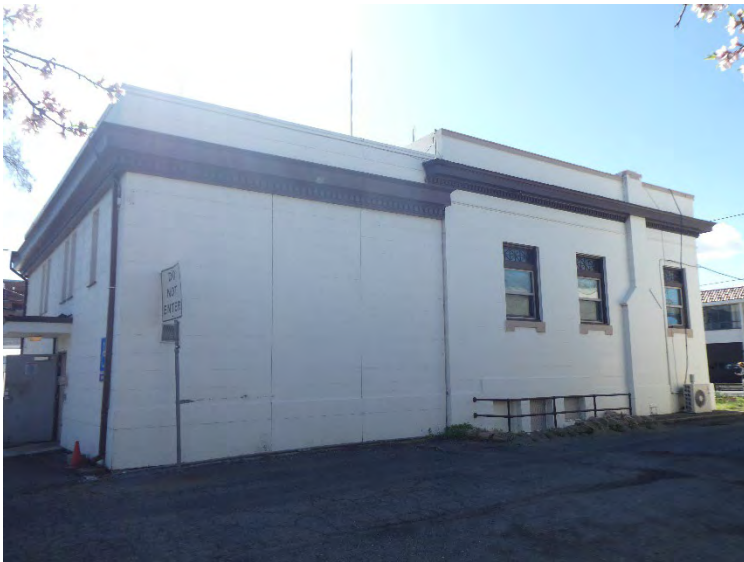
c) West Elevation

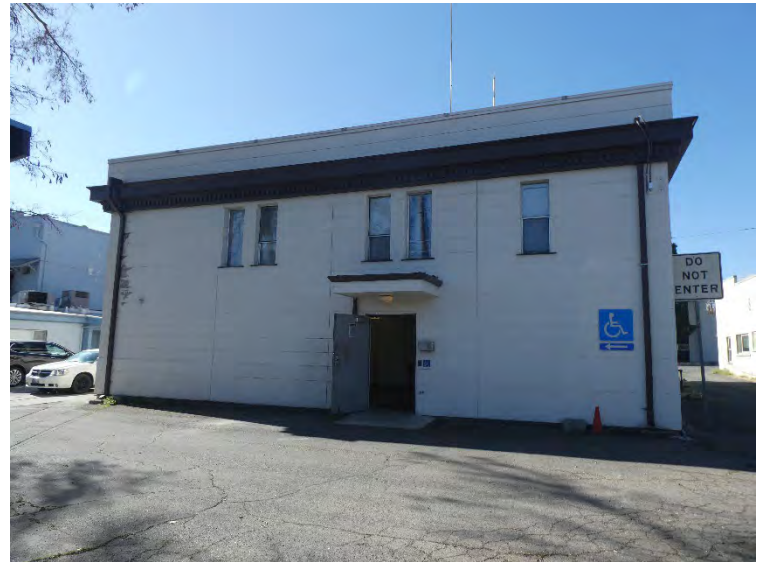
d) North (Rear) Elevation

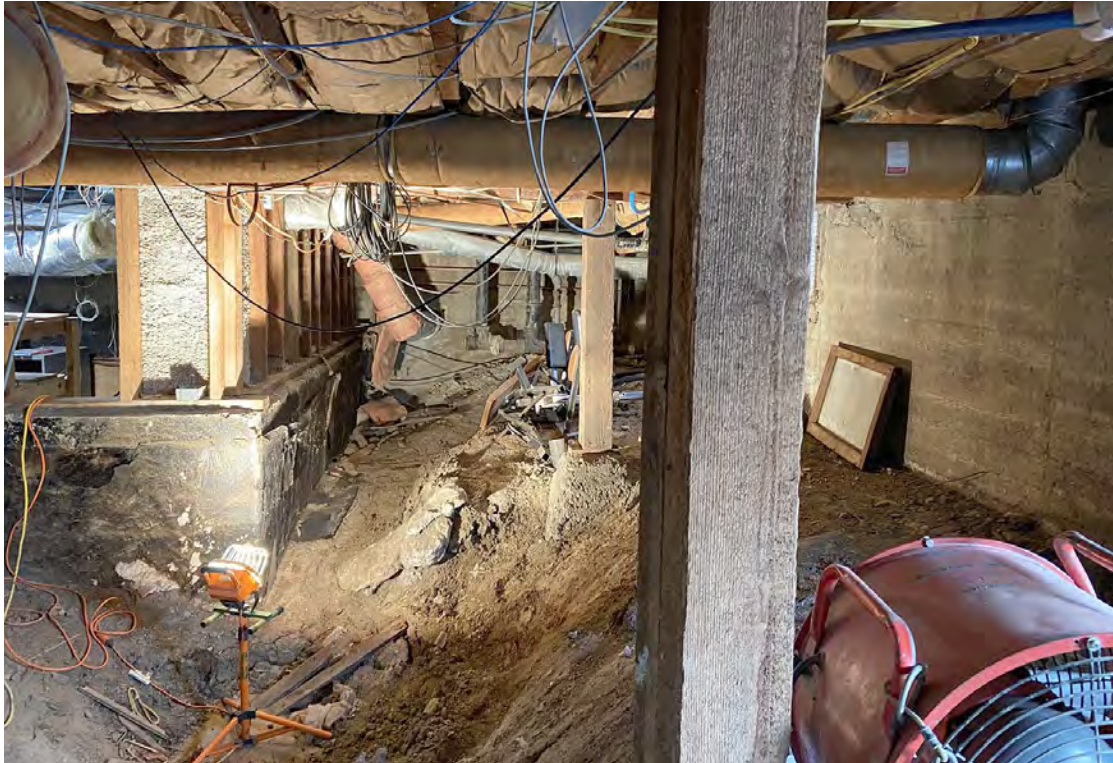
Photo No. 3 Utility conduits and trenching/excavation area in unfinished portion of basement

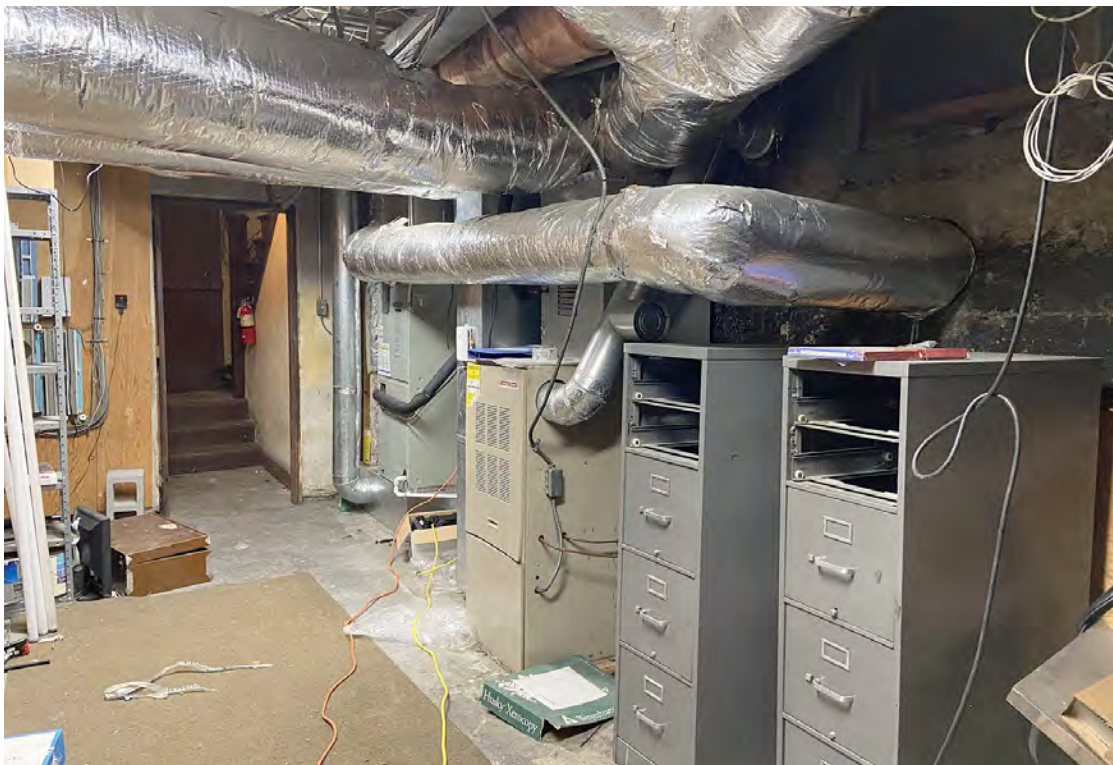
Photo No. 4 Furnace and air conditioning in the finished portion of the basement

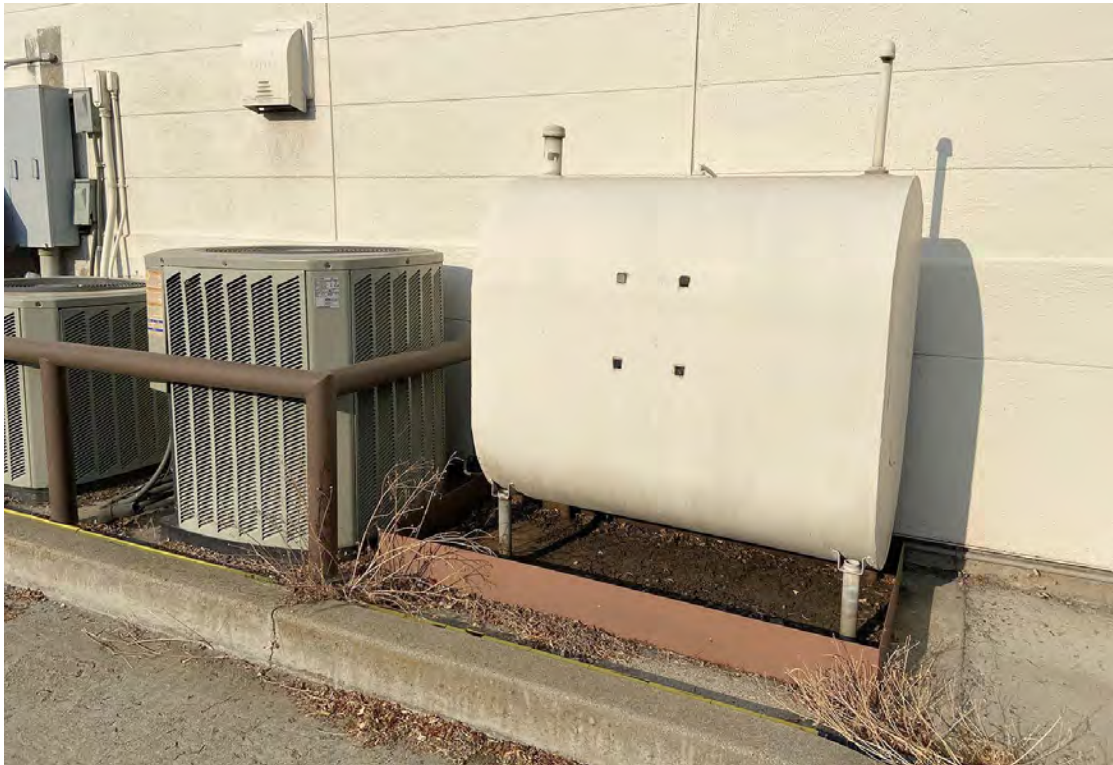
Photo No. 7 Kerosene AST in secondary containment on eastern side of site building

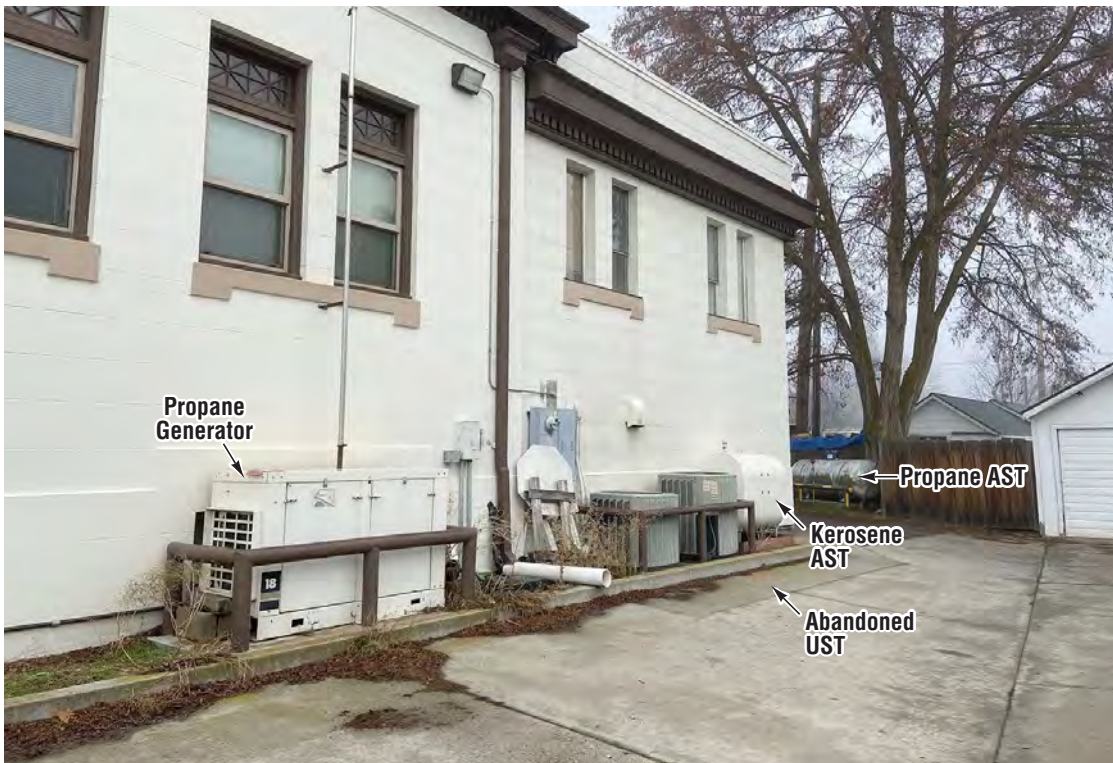
Photo No. 8 Propane powered generator and concrete patching over UST on the east side of the site building

A Phase I Environmental Site Assessment (ESA) prepared for the project identified one abandoned-in-place underground storage tank (UST) as well as one UST that was removed in 1989 without proper soil sample documentation. Due to the age of the building, asbestos-containing materials and lead-containing paint could also be encountered. A Phase II ESA performed did not identify any contaminants in the soil and determined no further action was recommended. Removal of asbestos-containing materials and lead paint would be conducted in accordance with all recommendations in the Phase II ESA.

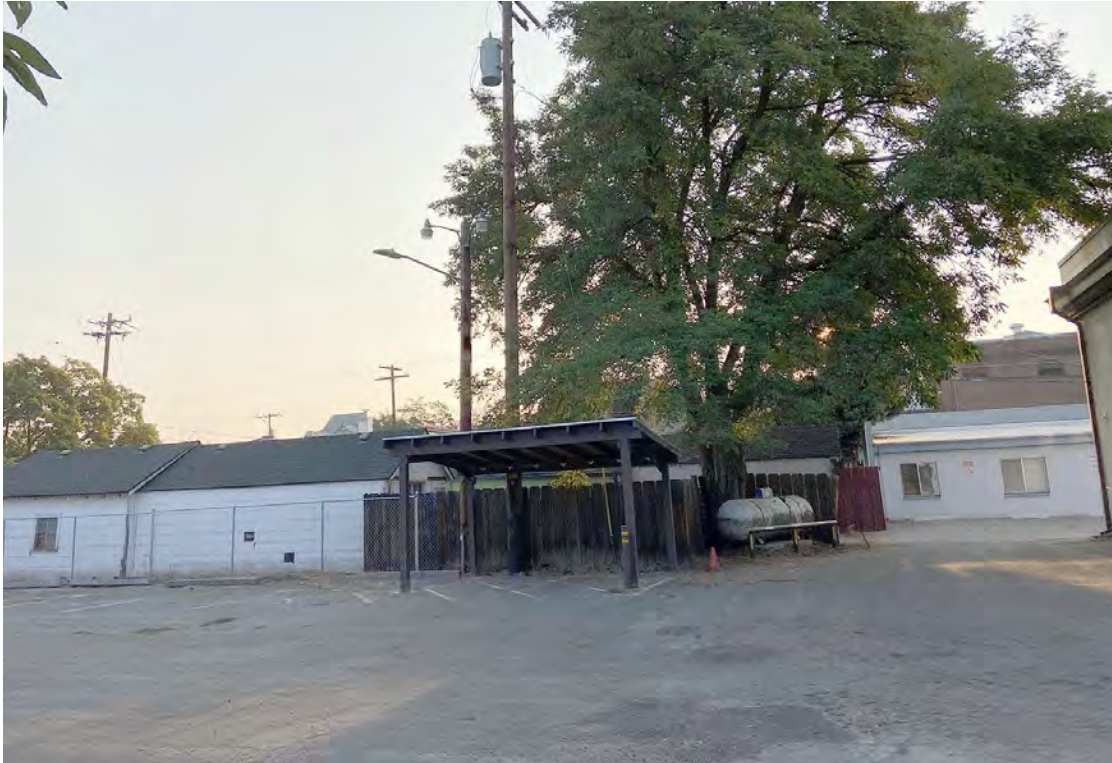
Photo No. 9 View to the east of propane AST and pole-mounted transformer in central portion of the Site

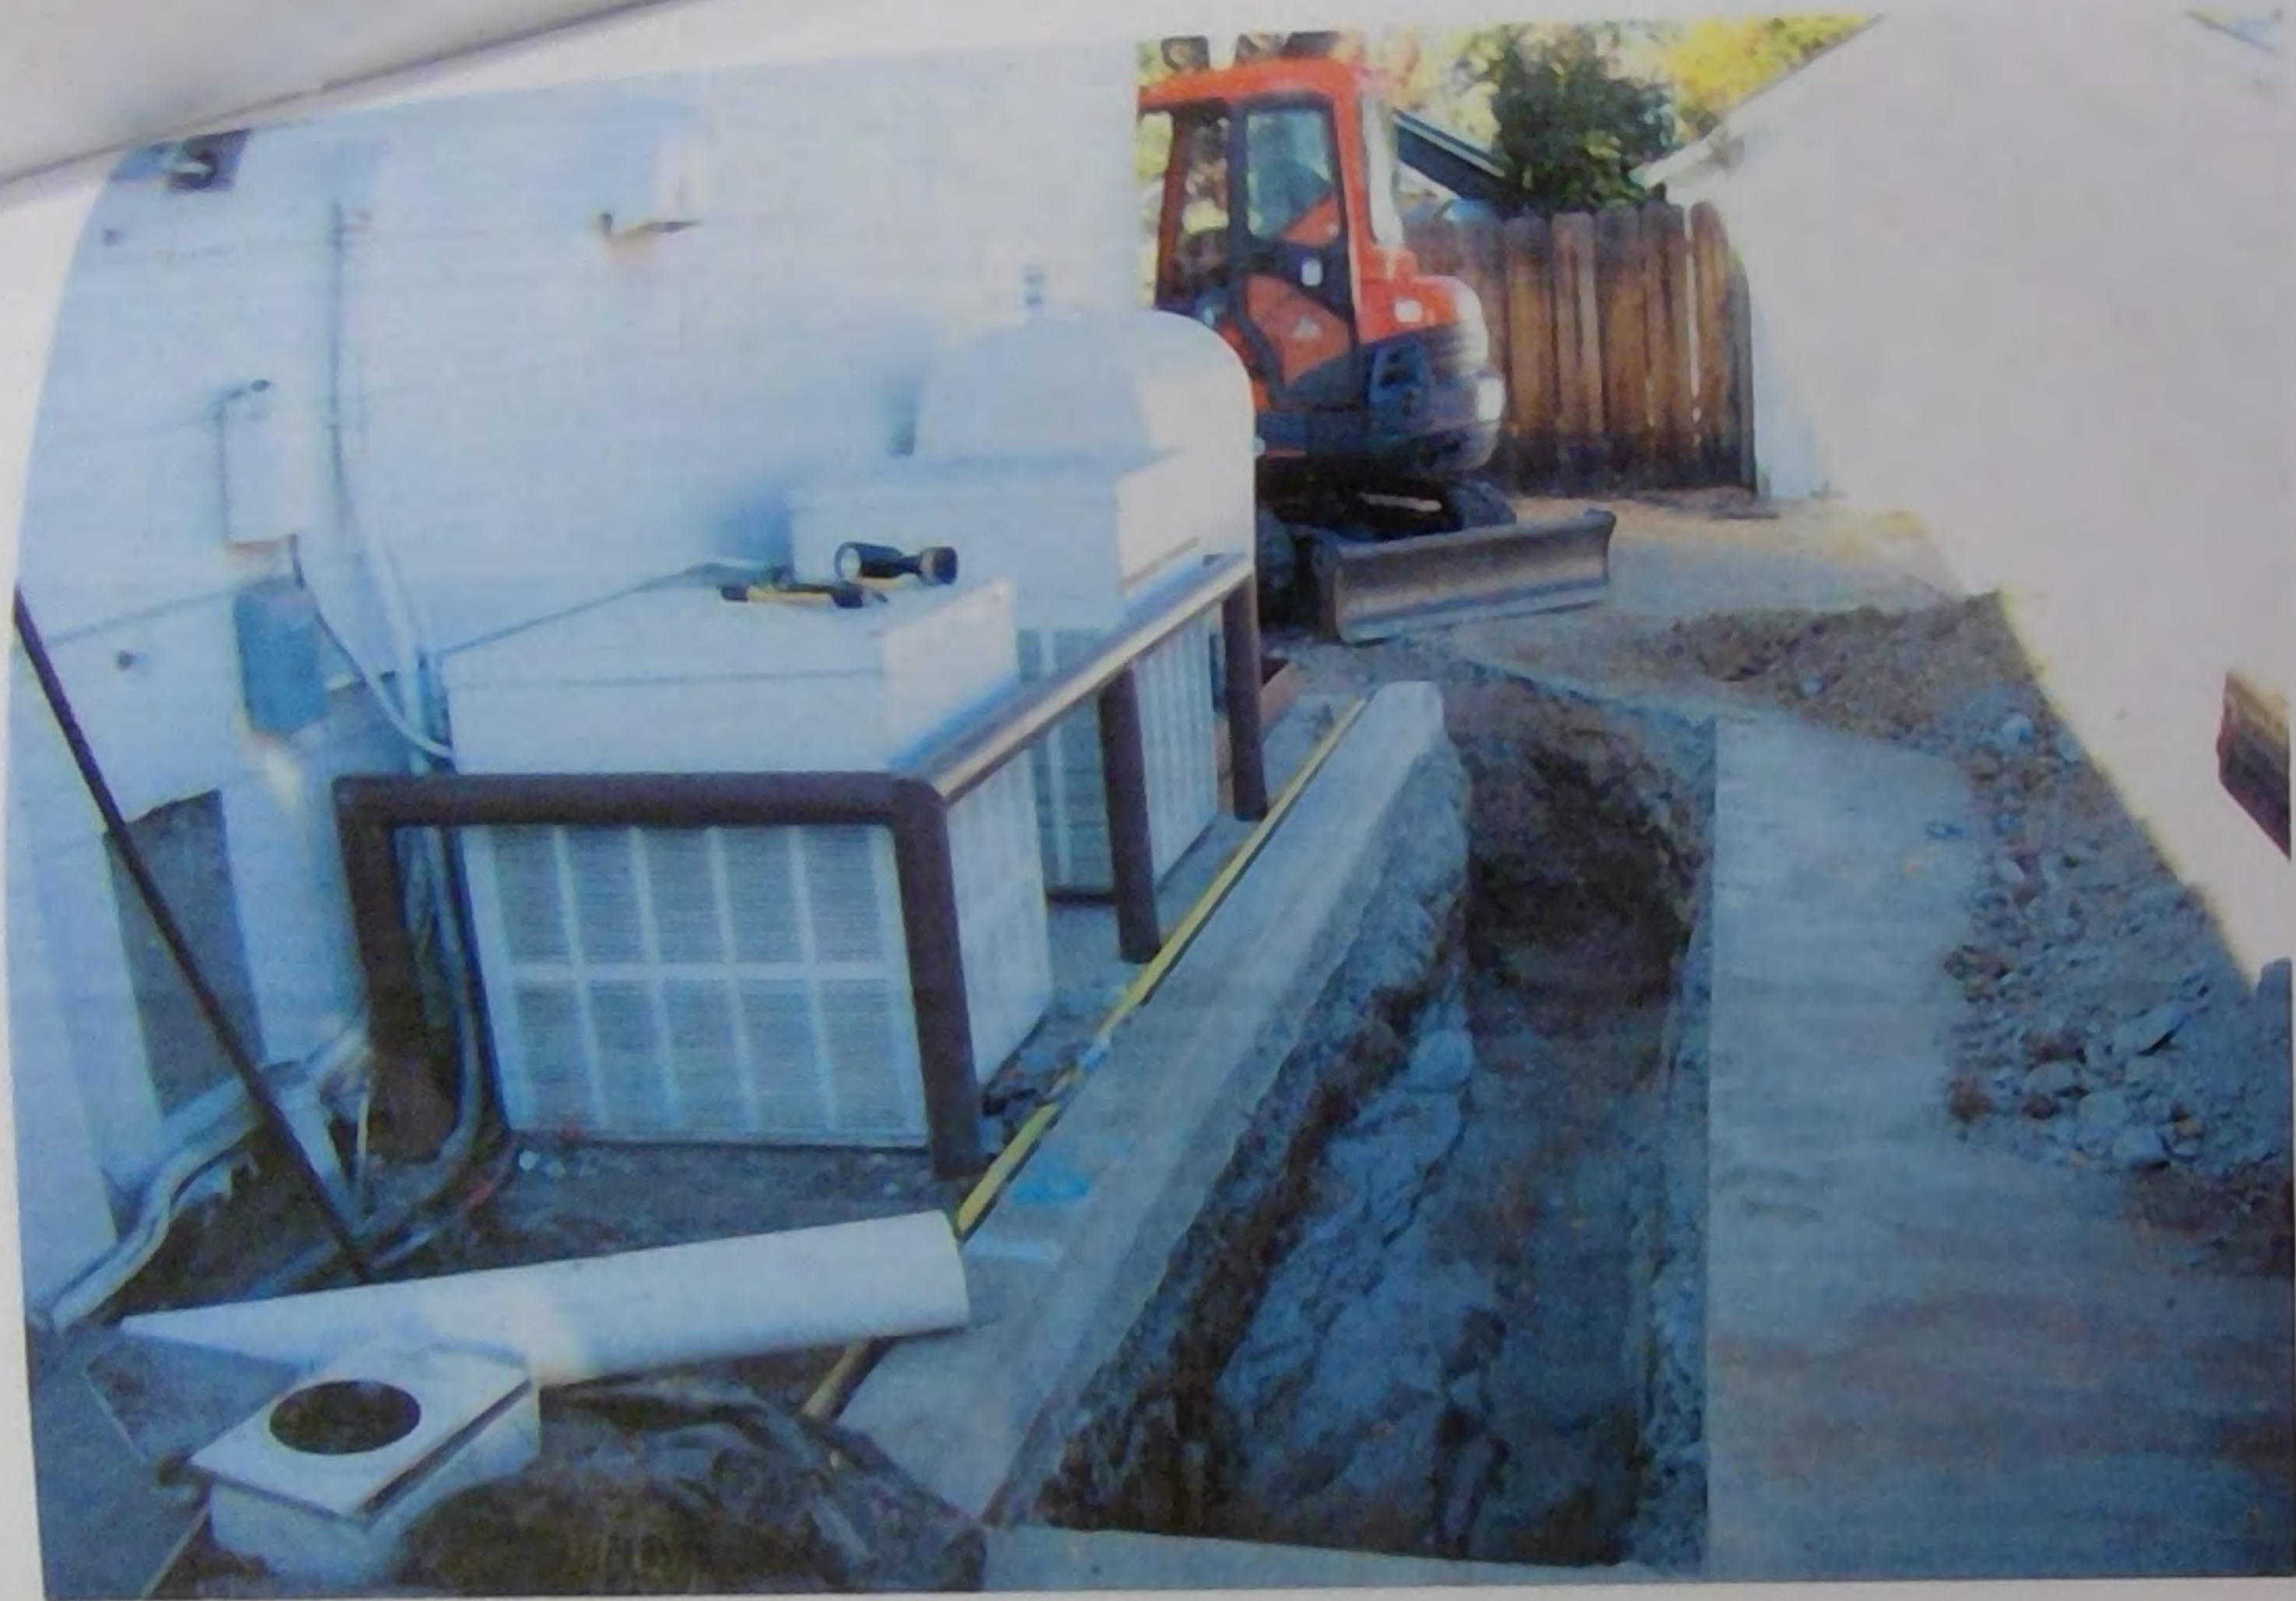
Taken by Chief Brian Bowles 10-25-11
old diesel tank filled with slurry to
within 4" of top @ vent pipe. No visible
or smell of diesel in soil. Tank was pumped
out and filled with slurry by Evans const.
per Mark Radelli who was there at the
time. Rick Bettis supervised the work for
Evans Construction.

Met with Mary Frances Mulhugh,
Steve Baker, Brian Bowles to discuss
the tank issue. It was decided to be
a non-issue and work was to proceed
with the electrical. MFM researched
and the tank being less than 1100
gallons did not require removal.
