YREKA CARNEGIE LIBRARY REHABILITATION
 412 W MINER ST., YREKA, CA 96097

This HSR is intended to guide the rehabilitation of the Yreka Carnegie Library. The building is individually listed in the National Register of Historic Places (NRHP) in 1992 as part of the California Carnegie Libraries Multiple Property Listing (MPL). As such, the rehabilitation of the building must comply with Secretary of Interior's Standards for the Treatment of Historic Properties (Standards). The HSR is not prescriptive however and does not mandate specific rehabilitation or conservation work. Instead, it provides general recommendations for preserving the features of the Yreka Carnegie Library that are significant to their architectural character as well as recommendations for further enhancing their integrity of original design by replacing features that have been removed, while also making appropriate changes to suit new and modern amenities.

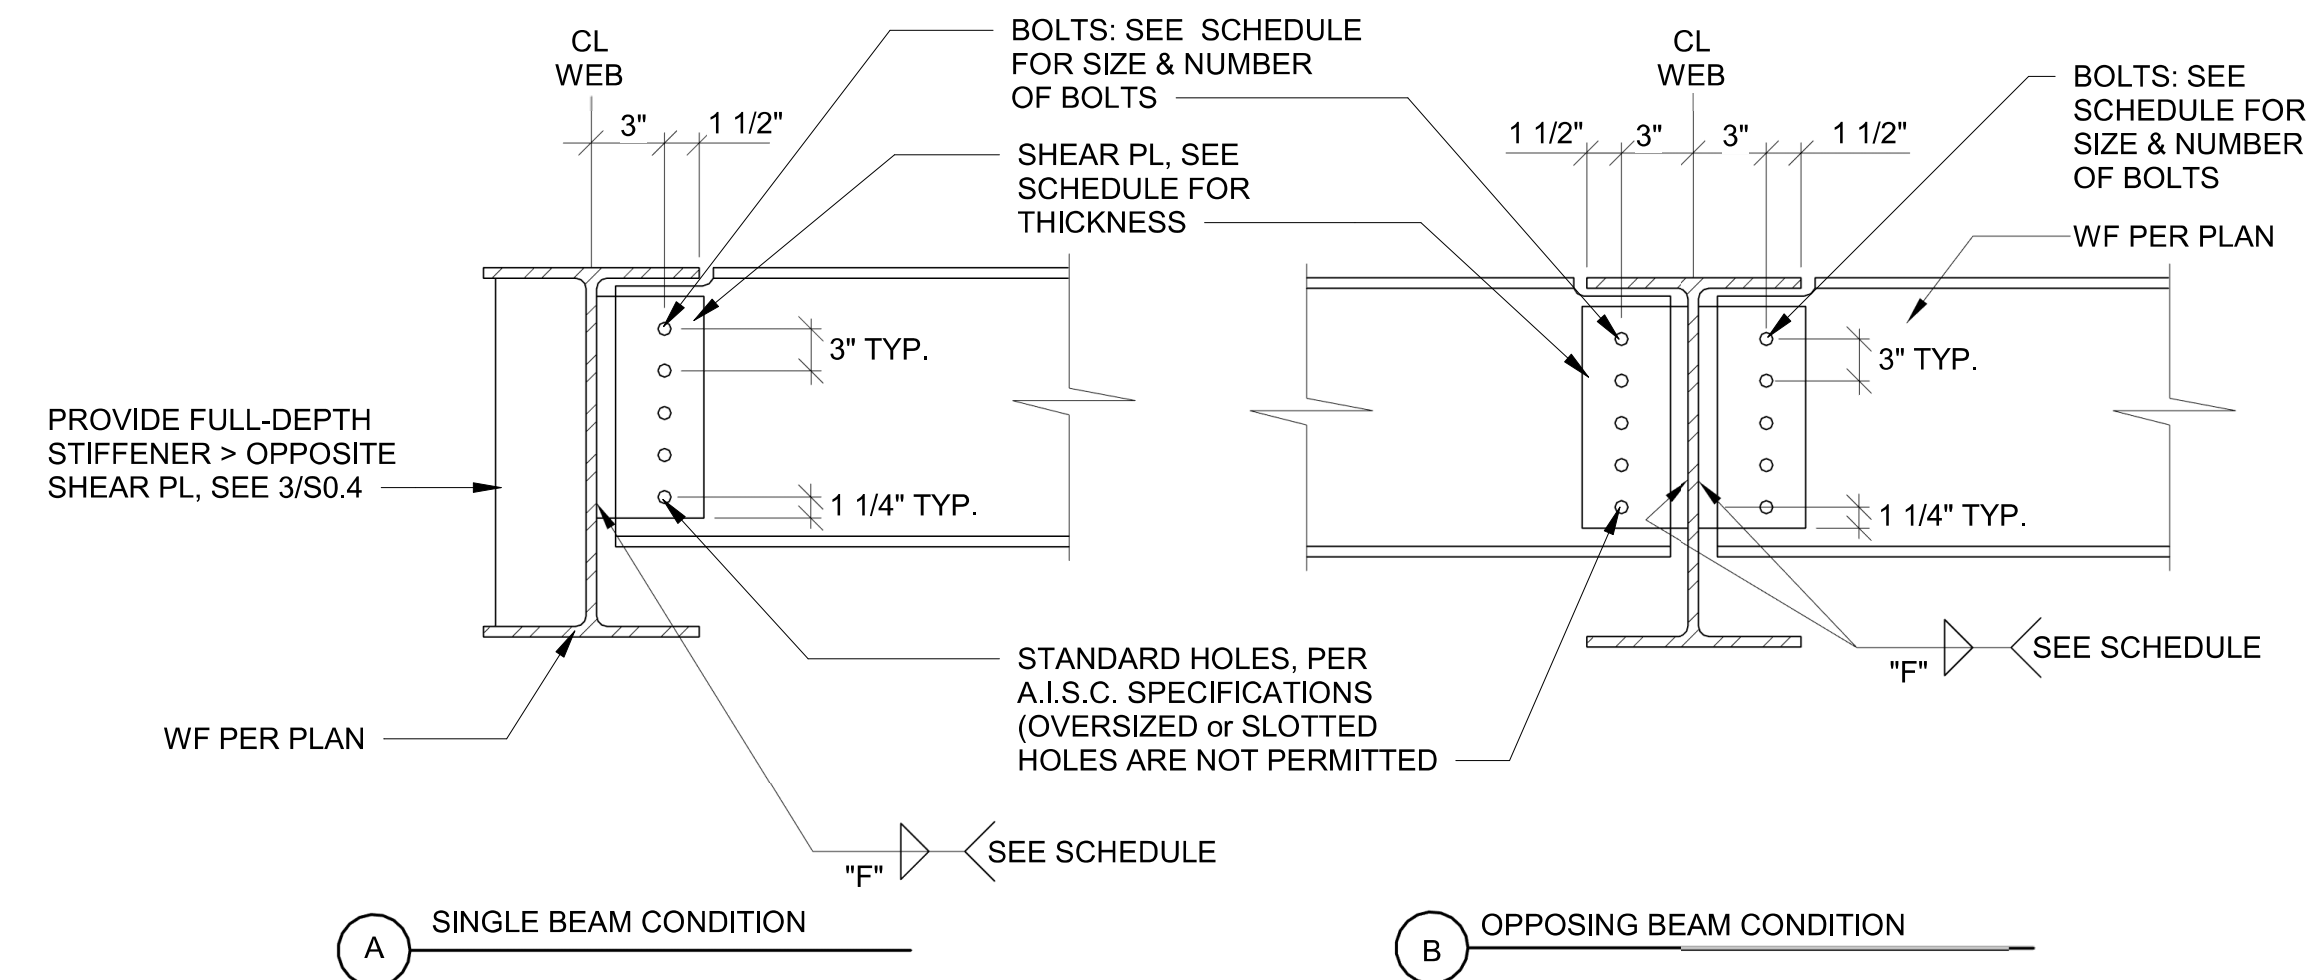
2 DETAIL
3/4" = 1'-0"

NOTE:
IF SHEAR PL'S ARE NOT DIRECTLY OPPOSING (OFFSETS OF 2" OR GREATER ARE NOT DIRECTLY OPPOSED) THEN PROVIDE STIFFENER PL OPPOSITE SHEAR PL PER CONDITION 'A'

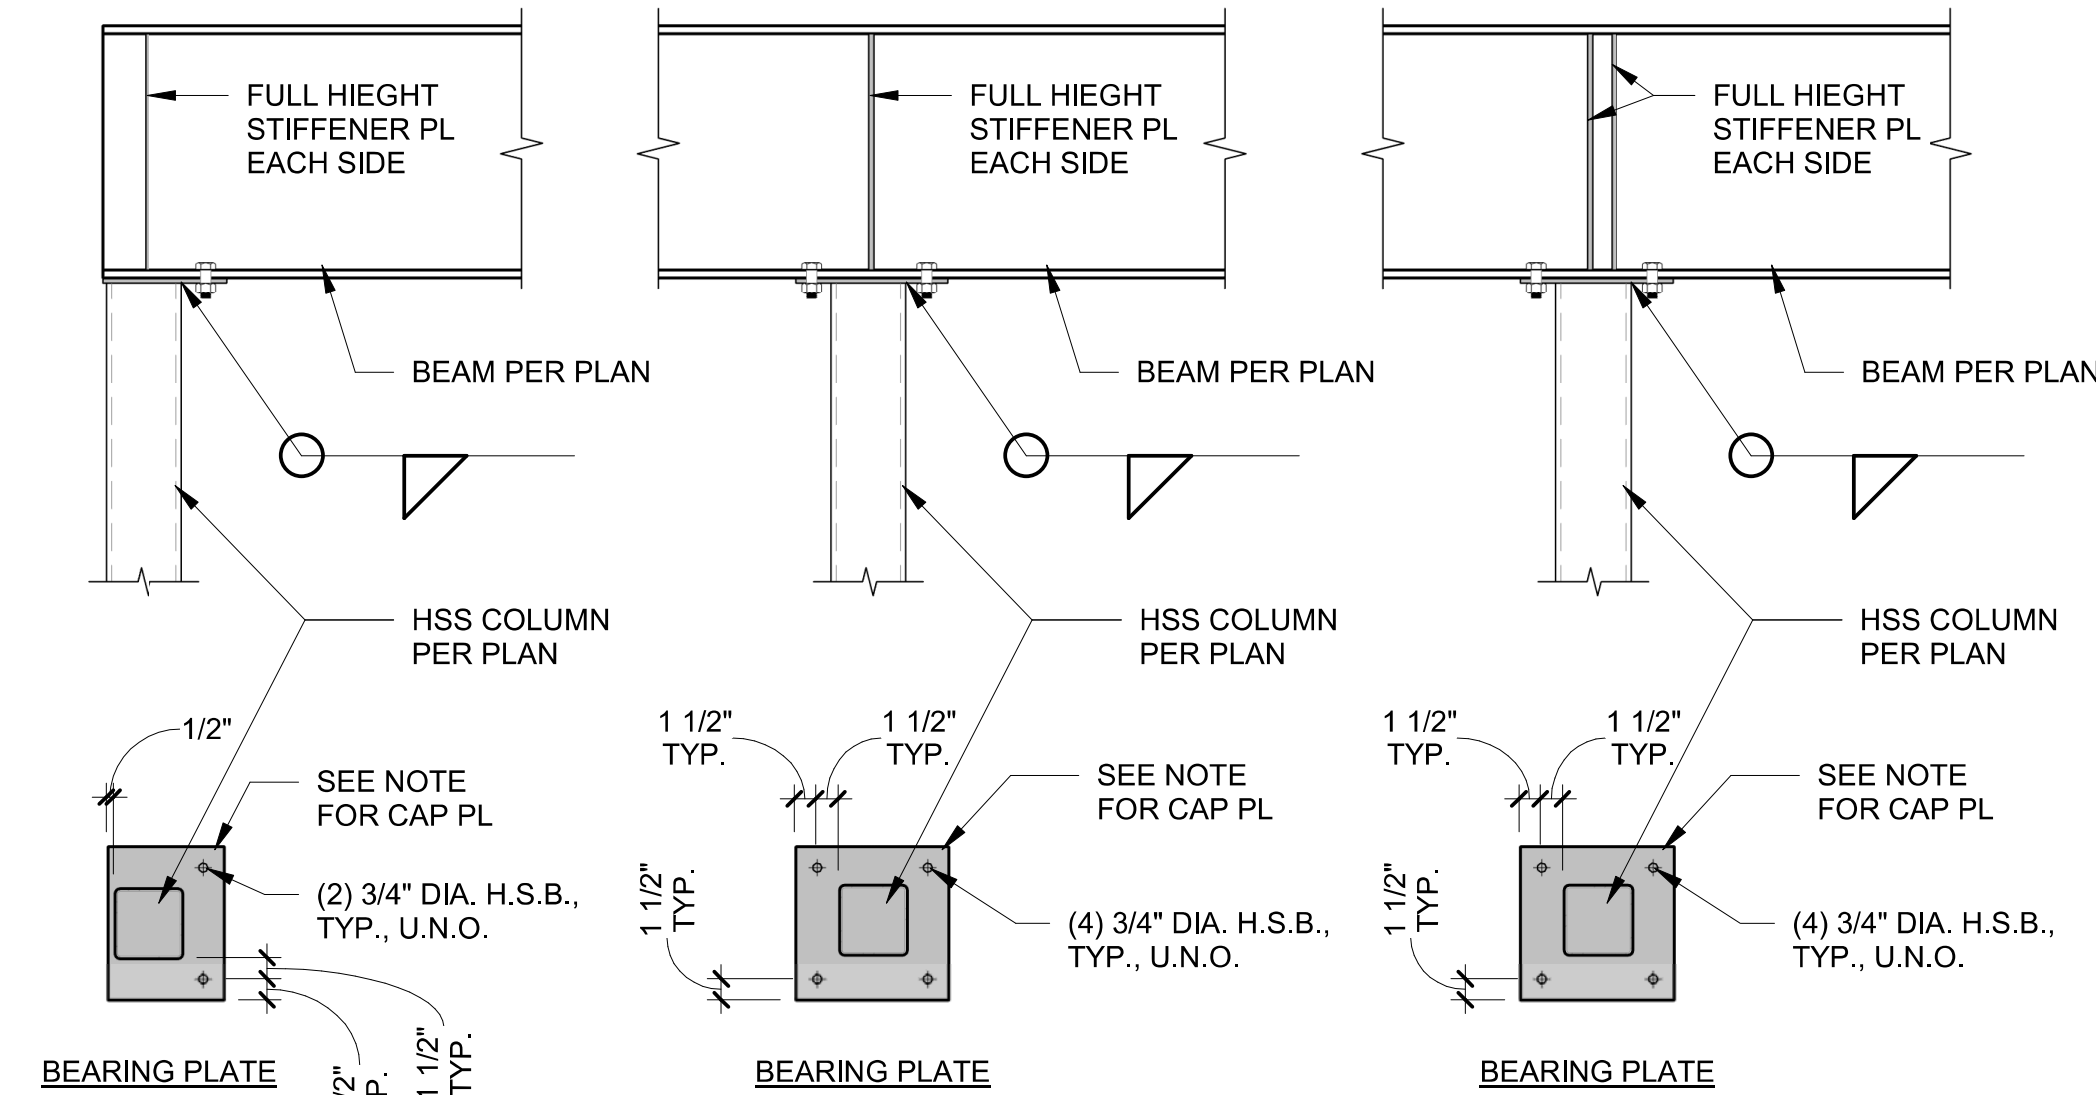
1 DETAIL
3/4" = 1'-0"

NOTE:
COLUMN CAP PL SHALL BE THE SAME WIDTH AS THE BEAM FLANGE or (COLUMN DIMENSION + 1/2") WHICHEVER IS GREATER. THICKNESS SHALL BE SAME THICKNESS AS BEAM FLANGE (1/2" MIN.)

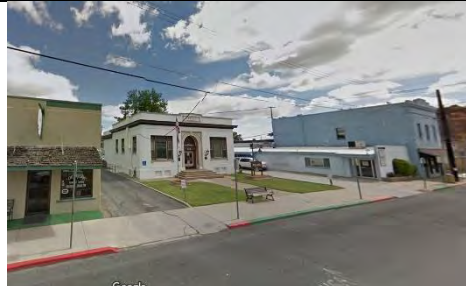
Table 1: Overall Visual Character			
Feature	Photo (if applicable)	Importance: Reason	Condition/Alterations
Immediate Setting <ul style="list-style-type: none"> • Setback from sidewalk • Central walkway from street

Primary: <ul style="list-style-type: none"> • Original • Highly visible • Minimally altered since the end of the period of significance 	Good. No alterations observed.

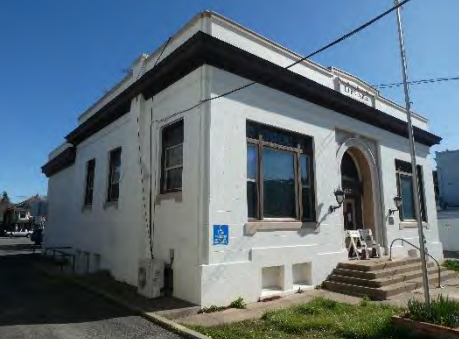
Feature	Photo (if applicable)	Importance: Reason	Condition/Alterations
<p>Original Massing</p> <ul style="list-style-type: none"> • Rectangular plan • One story with basement • Flat roof

<p>Primary:</p> <ul style="list-style-type: none"> • Original • Highly visible • Directly related to historic significance under A/C • Minimally altered since the end of the period of significance 	<p>Good.</p> <p>Alterations include a rear two-story addition completed outside the period of significance.</p>
<p>Roof Form</p> <ul style="list-style-type: none"> • Flat with raised parapet

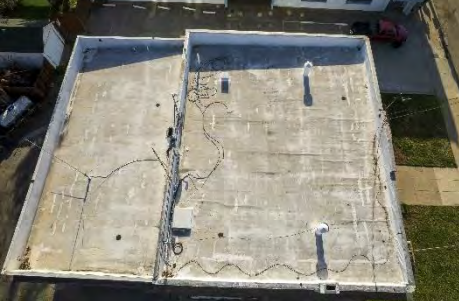
<p>Primary:</p> <ul style="list-style-type: none"> • Original • Highly visible • Minimally altered since the end of the period of significance 	<p>Good.</p> <p>No major alterations observed.</p>
<p>West Miner Street (South) Elevation</p> <ul style="list-style-type: none"> • Street-facing • One story • Three Bays • Main Entrance • Tripartite composition • Symmetrical design

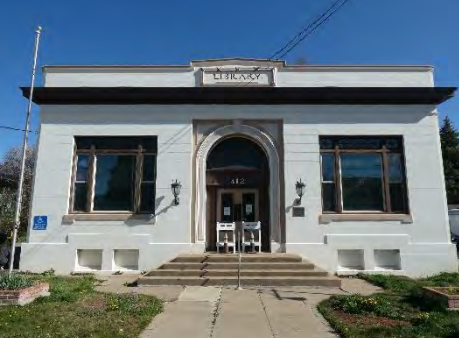
<p>Primary:</p> <ul style="list-style-type: none"> • Original • Highly visible • Directly related to historic significance under Criteria A/C • Minimally altered since the end of the period of significance 	<p>Good.</p> <p>No major alterations observed.</p>

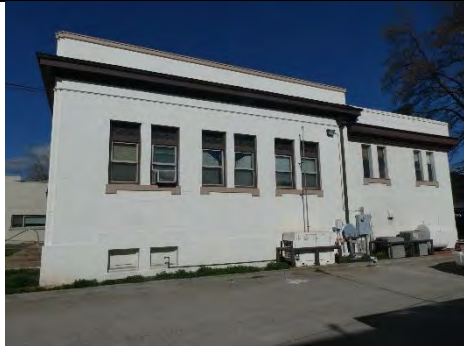
Table 1: Overall Visual Character			
Feature	Photo (if applicable)	Importance: Reason	Condition/Alterations
East Elevation (Original Building) <ul style="list-style-type: none"> • Side-facing • One story • Symmetrical design

Secondary: <ul style="list-style-type: none"> • Original • Partially visible • Minimally altered since the end of the period of significance 	Good. No major alterations observed.
West Elevation (Original Building) <ul style="list-style-type: none"> • Side-facing • One and two stories • Symmetrical design

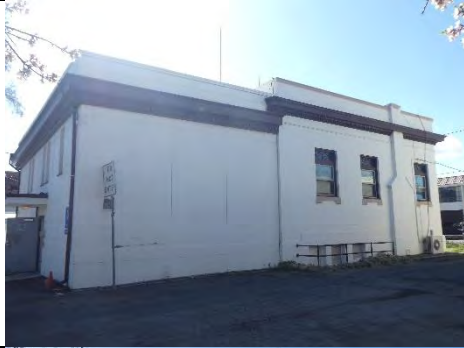
Secondary: <ul style="list-style-type: none"> • Original • Partially visible • Minimally altered since the end of the period of significance 	Good. No major alterations observed.
Rear (North) Elevation <ul style="list-style-type: none"> • Faces parking lot • Two stories • Rear Entrance

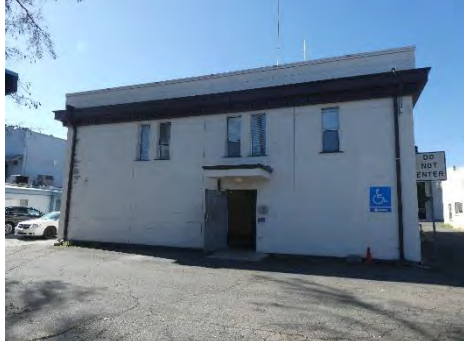
Not Character-Defining: <ul style="list-style-type: none"> • Postdates period of significance 	N/A. Project team noted cracking in masonry and water damage to cornice line.

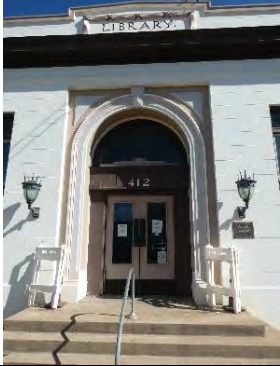
Table 1: Overall Visual Character			
Feature	Photo (if applicable)	Importance: Reason	Condition/Alterations
Main Entrance Configuration <ul style="list-style-type: none"> • South elevation • Centralized • Recessed within arched opening • Accessed by stairs

Primary: <ul style="list-style-type: none"> • Original • Partially visible • Directly related to historic significance under Criteria A/C • Minimally altered since the end of the period of significance 	Good. No major alterations observed.
Basement Entrance Configuration <ul style="list-style-type: none"> • West elevation • Below grade

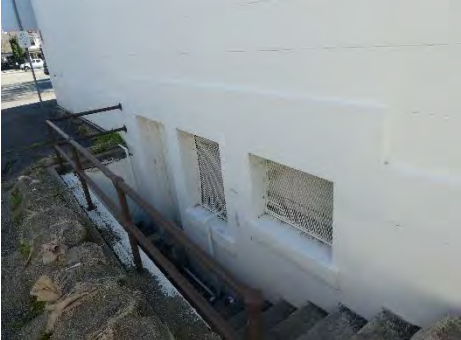
Not Character-Defining: <ul style="list-style-type: none"> • Partially visible • Utilitarian function/design • Common materials 	Good. No major alterations observed.
Rear Entrance Configuration <ul style="list-style-type: none"> • North elevation • Flush entry Arranged under flat canopy

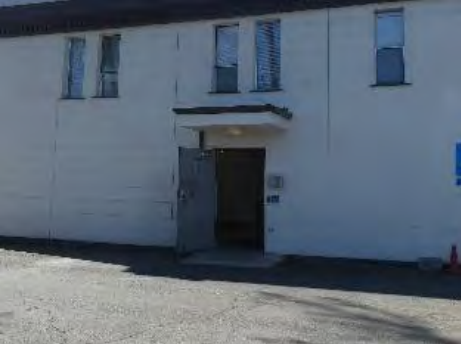
Not Character-Defining <ul style="list-style-type: none"> • Postdates the period of significance 	N/A

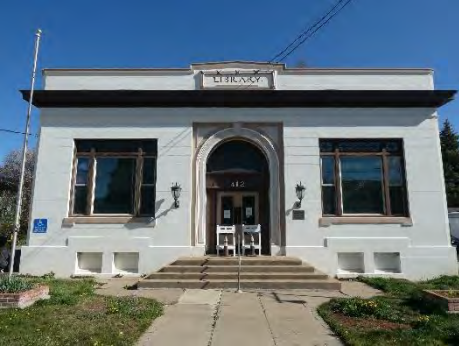
Table 1: Overall Visual Character			
Feature	Photo (if applicable)	Importance: Reason	Condition/Alterations
<p>Original Window Openings</p> <ul style="list-style-type: none"> • South, east, and west elevations of original building • Second floor • Tall, narrow rectangular • Recessed into elevation

<p>Primary:</p> <ul style="list-style-type: none"> • Original • Highly visible • Directly related to historic significance under Criteria A/C • Minimally altered since the end of the period of significance 	<p>Good.</p> <p>No major alterations observed.</p>
<p>Non-Original Window Openings</p> <ul style="list-style-type: none"> • North and east elevations of 1980 addition • Main floor and basement level • Square and rectangular • Recessed into elevation

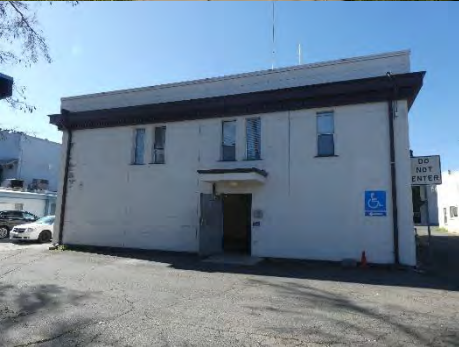
<p>Not Character-Defining:</p> <ul style="list-style-type: none"> • Postdates period of significance 	<p>N/A</p>

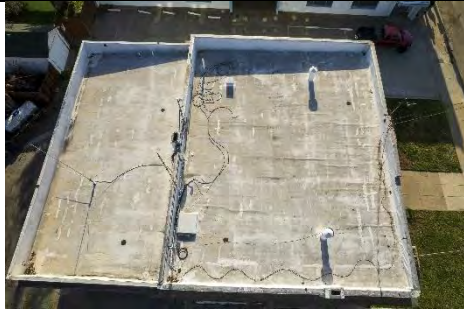
Table 2: Exterior Materials and Craftsmanship			
Feature	Photo (if applicable)	Importance: Reason	Condition/Alterations
Rolled Asphalt Surface of flat roof and canopy

Not Character-Defining: <ul style="list-style-type: none"> Minimally visible Utilitarian function/design Common material likely replaced over time 	N/A
Metal Coping <ul style="list-style-type: none"> All elevations, perimeter of parapet Metal Painted to match trim

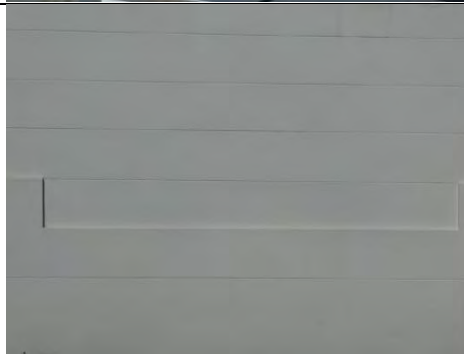
Primary: <ul style="list-style-type: none"> Original Highly visible Minimally altered since the end of the period of significance 	Fair to Good. Minor cracking and chipping observed. No alterations observed.

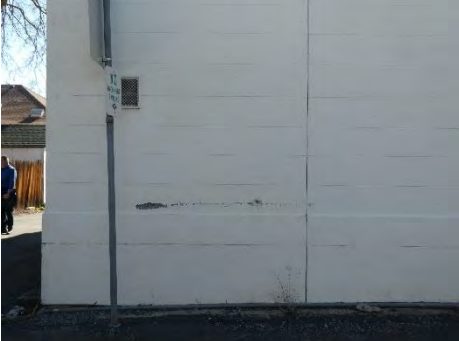
Feature	Photo (if applicable)	Importance: Reason	Condition/Alterations
<p>Cement Plaster (Non-Original)</p> <ul style="list-style-type: none"> • North, east, and west elevations of 1980 addition • Horizontal score lines • Painted

<p>Not Character-Defining:</p> <ul style="list-style-type: none"> • Postdates period of significance 	<p>N/A</p>
<p>Chimney</p> <ul style="list-style-type: none"> • West elevation • Cement plaster • Painted • Narrow flue

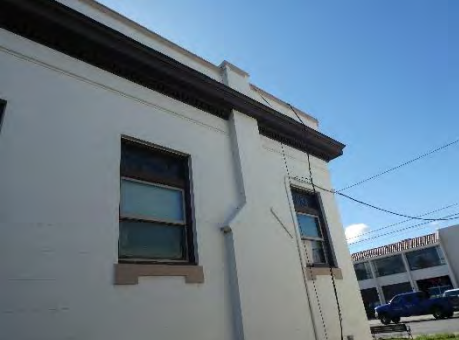
<p>Secondary:</p> <ul style="list-style-type: none"> • Original • Partially visible • Utilitarian in design/function • Minimally altered since the end of the period of significance 	<p>Good.</p> <p>No major alterations observed.</p>
<p>Wood (Painted)</p> <ul style="list-style-type: none"> • All elevations • Cornice • Main entrance doors and door frames • Windows and window frames on south, east and west elevations of original building

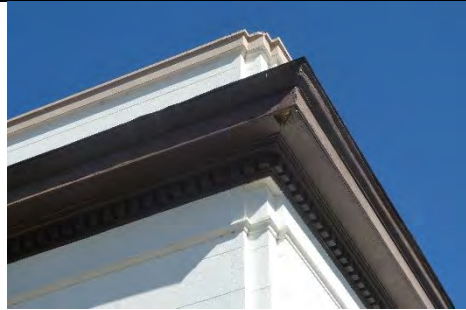
Table 2: Exterior Materials and Craftsmanship			
Feature	Photo (if applicable)	Importance: Reason	Condition/Alterations
Cornice (Original) <ul style="list-style-type: none"> • South, east, and west elevations of original building • Painted wood • Dentil detail along bottom edge

Primary: <ul style="list-style-type: none"> • Original • Highly visible • Directly related to historic significance under Criteria A/C • Minimally altered since the end of the period of significance 	Fair to Good. Water damage at corners of cornice observed No major alterations observed.
Cornice (Non-Original) <ul style="list-style-type: none"> • North, east, and west elevations of 1980 addition, • Painted wood • Dentil detail along bottom edge

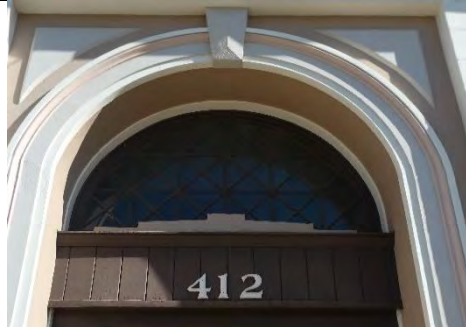
Not Character-Defining: <ul style="list-style-type: none"> • Postdates period of significance 	N/A
Fanlight Window <ul style="list-style-type: none"> • S1-W2 • South elevation • Painted wood frame, sash, and muntins • Geometric muntin pattern

Primary: <ul style="list-style-type: none"> • Original • Highly visible • Directly related to historic significance under Criteria A/C • Minimally altered since the end of the period of significance 	Good. No major alterations observed.

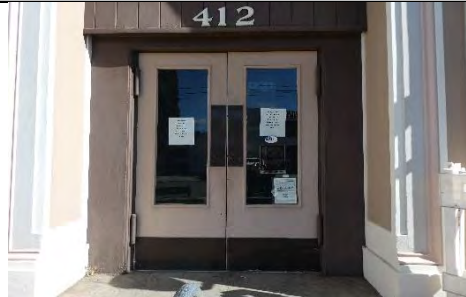
Feature	Photo (if applicable)	Importance: Reason	Condition/Alterations
<p>Main Entrance Door Frame</p> <ul style="list-style-type: none"> • South elevation • Painted wood • Large wood timbers • Vertical siding on transom

<p>Primary:</p> <ul style="list-style-type: none"> • Original • Highly visible • Minimally altered since the end of the period of significance 	<p>Good.</p> <p>Vertical wood siding appears to have been installed over transom at unknown date.</p>
<p>Main Entrance Door</p> <ul style="list-style-type: none"> • S1-D1 • South elevation • Painted wood • Paired • Fully glazed • Metal push and kickplates

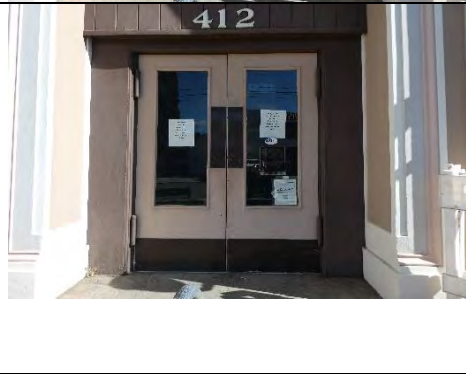
<p>Primary:</p> <ul style="list-style-type: none"> • Original • Highly visible • Replaced in kind at an unknown date 	<p>Fair to Good.</p> <p>Scratches, gouges, and other signs of wear-and-tear observed at inner edge of both doors.</p> <p>Doors appear to have been compatibly replaced at an unknown date.</p>

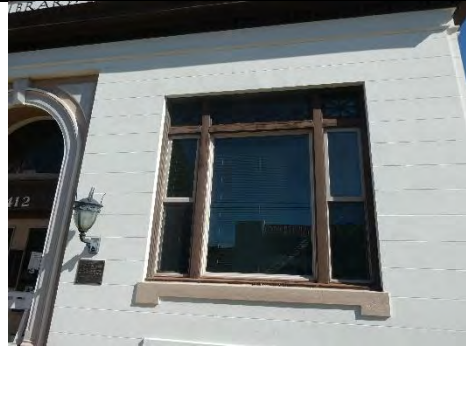
<p>Primary:</p> <ul style="list-style-type: none"> • Original • Highly visible • Minimally altered since the end of the period of significance 	<p>Fair. Wood transom and muntins showing signs of deterioration, likely caused by excess moisture.</p> <p>Double-hung wood sashes appear to have been replaced in-kind at an unknown date.</p>

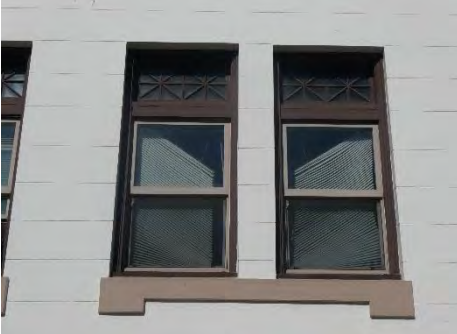
Feature	Photo (if applicable)	Importance: Reason	Condition/Alterations
<p>Paired Double-Hung Windows</p> <ul style="list-style-type: none"> • E1-W1 through E1-W6 • East elevation • Painted wood frame, sash, muntins, and transom • One-over-one double-hung • Transom window with geometric muntins

<p>Primary:</p> <ul style="list-style-type: none"> • Original • Highly visible <p>Minimally altered since the end of the period of significance</p>	<p>Good.</p> <p>Double-hung wood sashes appear to have been replaced in kind at an unknown date.</p>
<p>Single Double-Hung Windows</p> <ul style="list-style-type: none"> • W1-W1 through W1-W3 • West elevation • Painted wood frame, sash, muntins, and transom • One-over-one double-hung • Transom window with geometric muntins

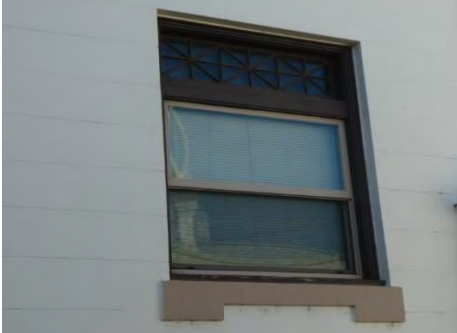
<p>Primary:</p> <ul style="list-style-type: none"> • Original • Highly visible <p>Minimally altered since the end of the period of significance</p>	<p>Good.</p> <p>Double-hung wood sashes appear to have been replaced in kind at an unknown date.</p>

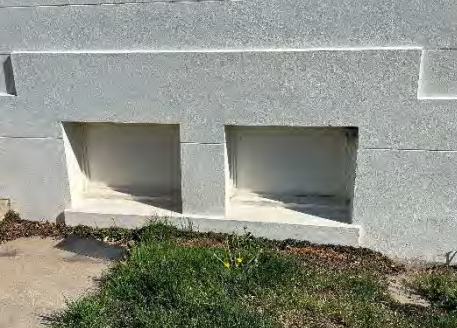
<p>Secondary:</p> <ul style="list-style-type: none"> • Original • Partially visible • Utilitarian in design/function • Altered since the end of the period of significance 	<p>Fair.</p> <p>Glazing has been painted at an unknown date.</p>

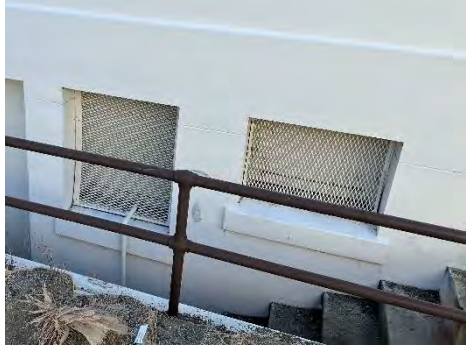
Not Character-Defining: <ul style="list-style-type: none"> • Less visible • Utilitarian in design/function • Altered since the end of the period of significance 	Fair. Glazing has been painted at an unknown date, metal security mesh installed over exterior of window openings at unknown date.
Cast Concrete <ul style="list-style-type: none"> • South, east, and west elevations of original building • Painted • Library Sign • Main entrance surround • Projecting window sills

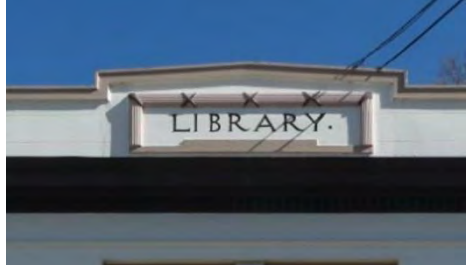
See individual features listed below.	See individual features below.
Library Sign <ul style="list-style-type: none"> • Center of south elevation parapet • Painted cast concrete • Incised letters Rectangular reed and ribbon frame

Primary: <ul style="list-style-type: none"> • Original • Highly visible • Directly related to historic significance under Criteria A/C • Minimally altered since the end of the period of significance 	Good. No alterations observed.

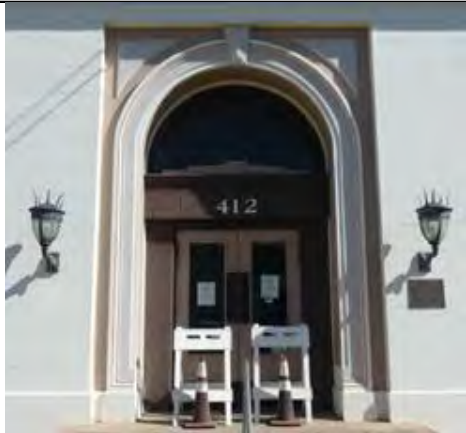
Table 2: Exterior Materials and Craftsmanship			
Feature	Photo (if applicable)	Importance: Reason	Condition/Alterations
<p>Main Entrance Surround</p> <ul style="list-style-type: none"> • South elevation • Painted cast concrete • Arched opening with keystone

<p>Primary:</p> <ul style="list-style-type: none"> • Original • Highly visible • Directly related to historic significance under Criteria A/C • Minimally altered since the end of the period of significance 	<p>Good.</p> <p>No major alterations observed.</p>
<p>Window Sills</p> <ul style="list-style-type: none"> • Under windows S1-W1, S1-W3, E1-W1 through E1-W-6, W1-W1 through W1-W3 • North, east, west elevation of original building • Painted cast concrete • Bracket-shaped

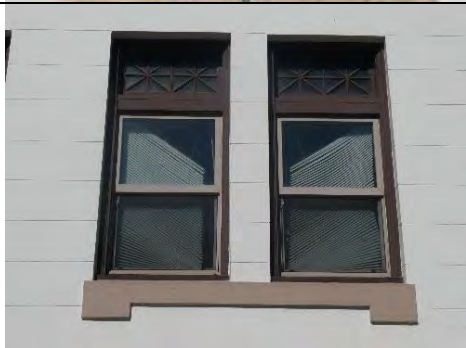
<p>Primary:</p> <ul style="list-style-type: none"> • Original • Highly visible • Minimally altered since the end of the period of significance 	<p>Good.</p> <p>No major alterations observed.</p>

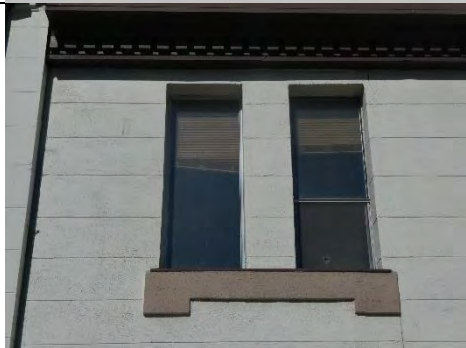
<p>Window Sills</p> <ul style="list-style-type: none"> • Under windows E2-W1 through E2-W4 • East elevation of 1980 addition • Cast concrete • Painted cast concrete • Bracket-shaped

<p>Not Character-Defining</p> <ul style="list-style-type: none"> • Postdates period of significance 	<p>N/A</p>

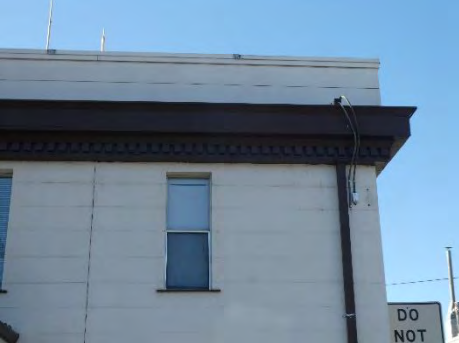
See individual features listed below.	See individual features below.
Downspouts <ul style="list-style-type: none"> • East and north elevation • Painted metal

Not Character-Defining <ul style="list-style-type: none"> • Postdates period of significance • Utilitarian function/design 	N/A
Address Numbers <ul style="list-style-type: none"> • South elevation • Painted Metal

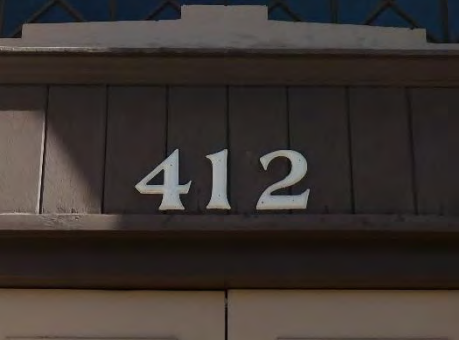
Not Character-Defining <ul style="list-style-type: none"> • Postdates period of significance • Common material 	N/A

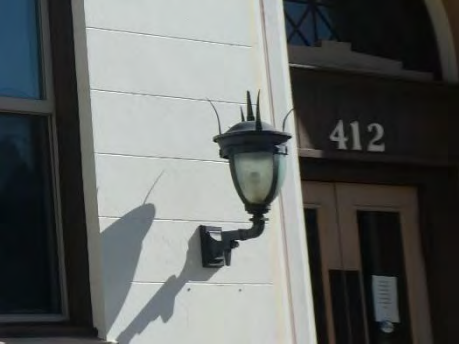
Feature	Photo (if applicable)	Importance: Reason	Condition/Alterations
<p>Light Fixtures</p> <ul style="list-style-type: none"> • South elevation • Painted metal • Lantern shape with decorative spikes • Mounted on arm/bracket

<p>Primary:</p> <ul style="list-style-type: none"> • Original • Highly visible • Minimally altered since the end of the period of significance 	<p>Good.</p> <p>No major alterations observed.</p>
<p>Front Yard Light</p> <ul style="list-style-type: none"> • South elevation • Painted metal • Fluted post with lantern on arm

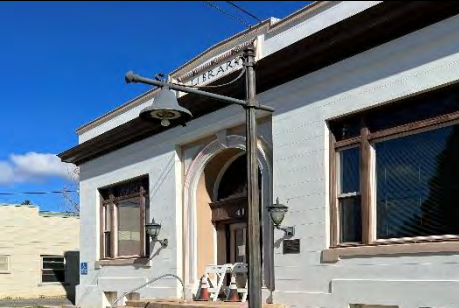
<p>Not Character-Defining</p> <ul style="list-style-type: none"> • Postdates period of significance 	<p>N/A</p>
<p>Rear Door</p> <ul style="list-style-type: none"> • N1-D1 • North elevation • Painted metal

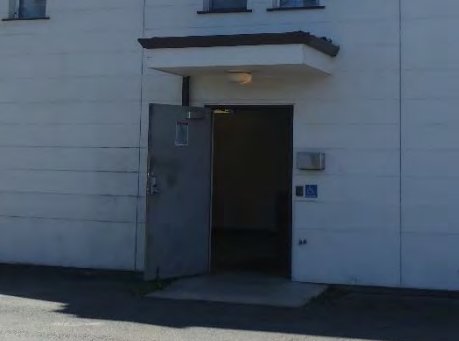
<p>Not Character-Defining</p> <ul style="list-style-type: none"> • Postdates period of significance 	<p>N/A</p>

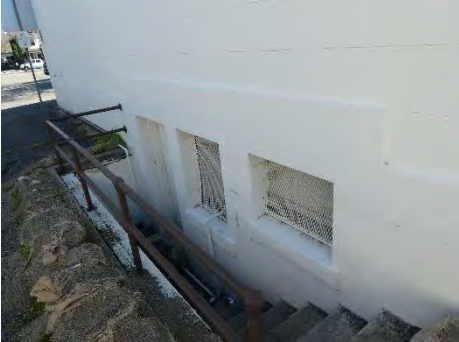
Feature	Photo (if applicable)	Importance: Reason	Condition/Alterations
Basement Door <ul style="list-style-type: none"> • WB-D1 • West elevation • Painted metal • Single door

Not Character-Defining <ul style="list-style-type: none"> • Partially visible • Utilitarian function/design Common material	Good. No alterations observed.
Basement Entry Stair Rail <ul style="list-style-type: none"> • West elevation • Painted Metal

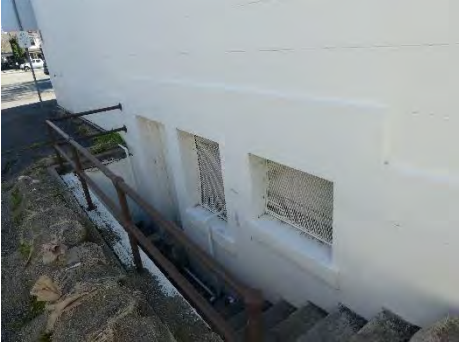
Not Character-Defining <ul style="list-style-type: none"> • Partially visible • Utilitarian function/design • Common material 	Good. No alterations observed.
Aluminum <ul style="list-style-type: none"> • South, east, and north elevation • Windows on 1980 addition • Main Entry handrail • Flagpole

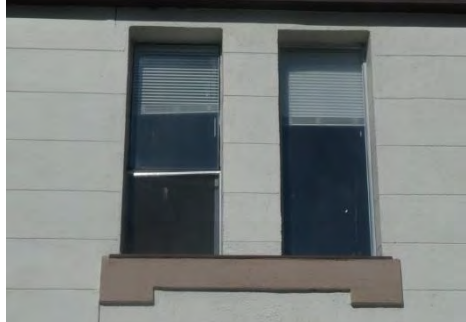
Feature	Photo (if applicable)	Importance: Reason	Condition/Alterations
<p>Aluminum Windows</p> <ul style="list-style-type: none"> • E2-W1 through E2-W4, N2-W1 through N2-W5 • North and east elevation of 1980 addition

<p>Not Character-Defining</p> <ul style="list-style-type: none"> • Postdates period of significance 	<p>N/A</p>
<p>Main Entry Stair Rail</p> <ul style="list-style-type: none"> • South elevation • Aluminum

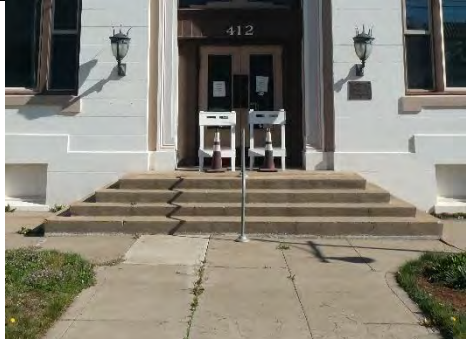
<p>Not Character-Defining</p> <ul style="list-style-type: none"> • Postdates period of significance 	<p>N/A</p>
<p>Flagpole</p> <ul style="list-style-type: none"> • South elevation • Aluminum

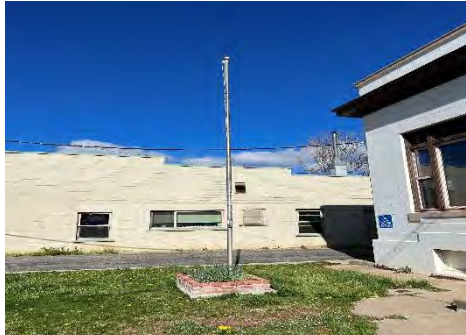
<p>Not Character-Defining</p> <ul style="list-style-type: none"> • Postdates period of significance 	<p>N/A</p>
