Table 2: Exterior Materials and Craftsmanship			
Feature	Photo (if applicable)	Importance: Reason	Condition/Alterations
Aluminum Windows <ul style="list-style-type: none"> E2-W1 through E2-W4, N2-W1 through N2-W5 North and east elevation of 1980 addition

Table 3: Interior Spaces (Original Building)

PART 2

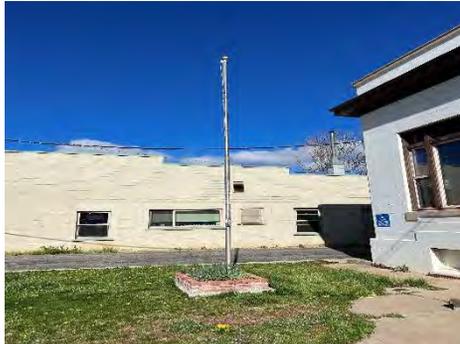
Not Character-Defining <ul style="list-style-type: none"> Postdates period of significance 	N/A
Flagpole <ul style="list-style-type: none"> South elevation Aluminum

Not Character-Defining <ul style="list-style-type: none"> Postdates period of significance 	N/A

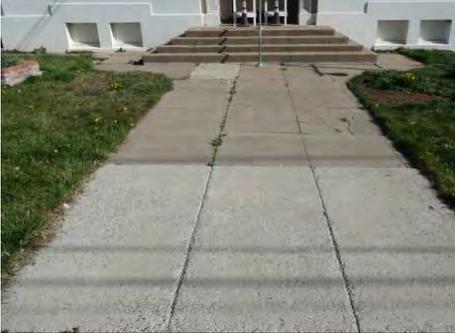
Table 2: Exterior Materials and Craftsmanship			
Feature	Photo (if applicable)	Importance: Reason	Condition/Alterations
Concrete <ul style="list-style-type: none"> • South elevation • Main entry stair • Centralized walkway • Basement Stair

See individual features listed below.	See individual features below.
Main Entry Stair <ul style="list-style-type: none"> • South elevation • Concrete

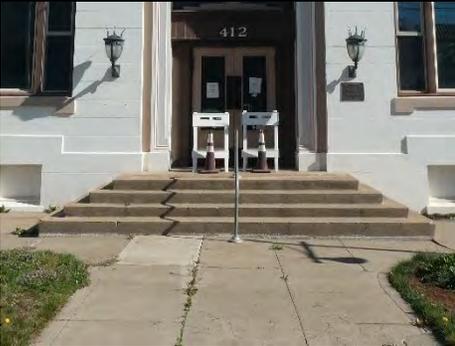
Secondary: <ul style="list-style-type: none"> • Original • Highly visible • Common material 	Fair to Good. Cracking and chipping observed, especially at edges of steps. No major alterations observed.
Centralized Walkway <ul style="list-style-type: none"> • South elevation • Concrete

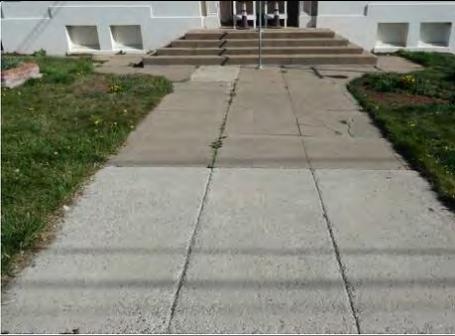
Secondary: <ul style="list-style-type: none"> • Original • Highly visible • Common material • Partially replaced since the end of the period of significance 	Fair to Good. Cracking and chipping observed. Walkway partially replaced with concrete of a different appearance/texture.

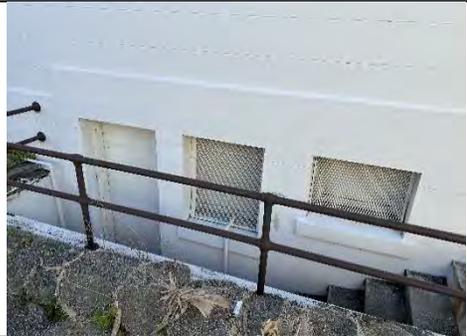
Table 2: Exterior Materials and Craftsmanship			
Feature	Photo (if applicable)	Importance: Reason	Condition/Alterations
Basement Stair

Not Character-Defining <ul style="list-style-type: none"> Partially visible Utilitarian function/design Common material 	N/A
Brick <ul style="list-style-type: none"> South elevation Planters for flagpole and former Yreka Police Department Sign

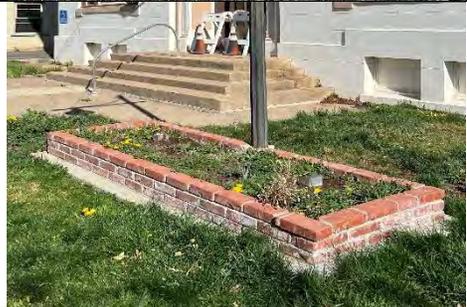
Not Character-Defining <ul style="list-style-type: none"> Postdates period of significance 	N/A

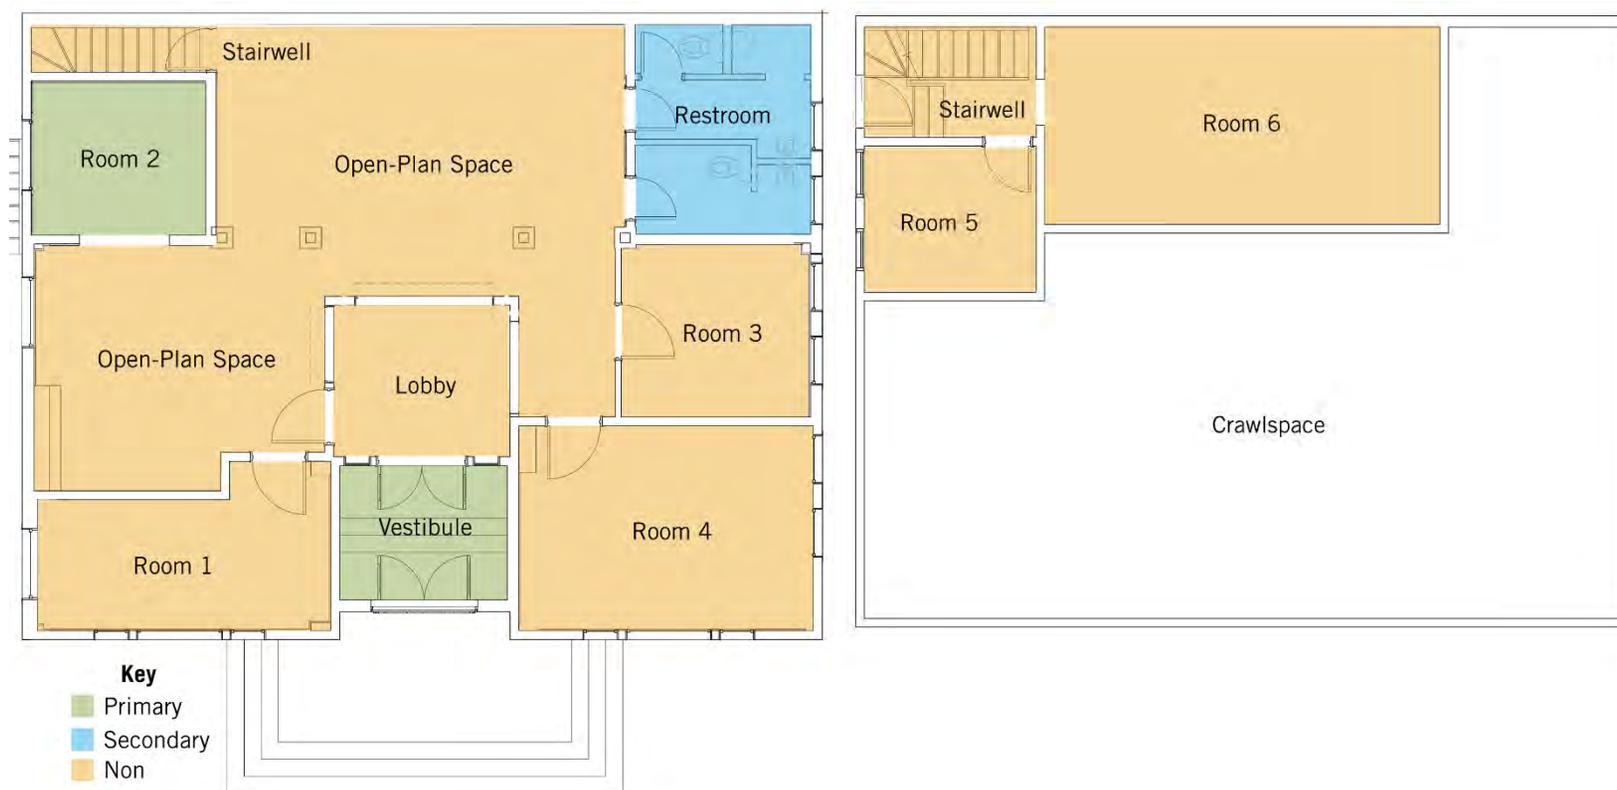
Figure 14 (LEFT): Primary, secondary, and non-character-defining spaces on the main floor. (ORW Architecture, annotated by GPA Consulting).

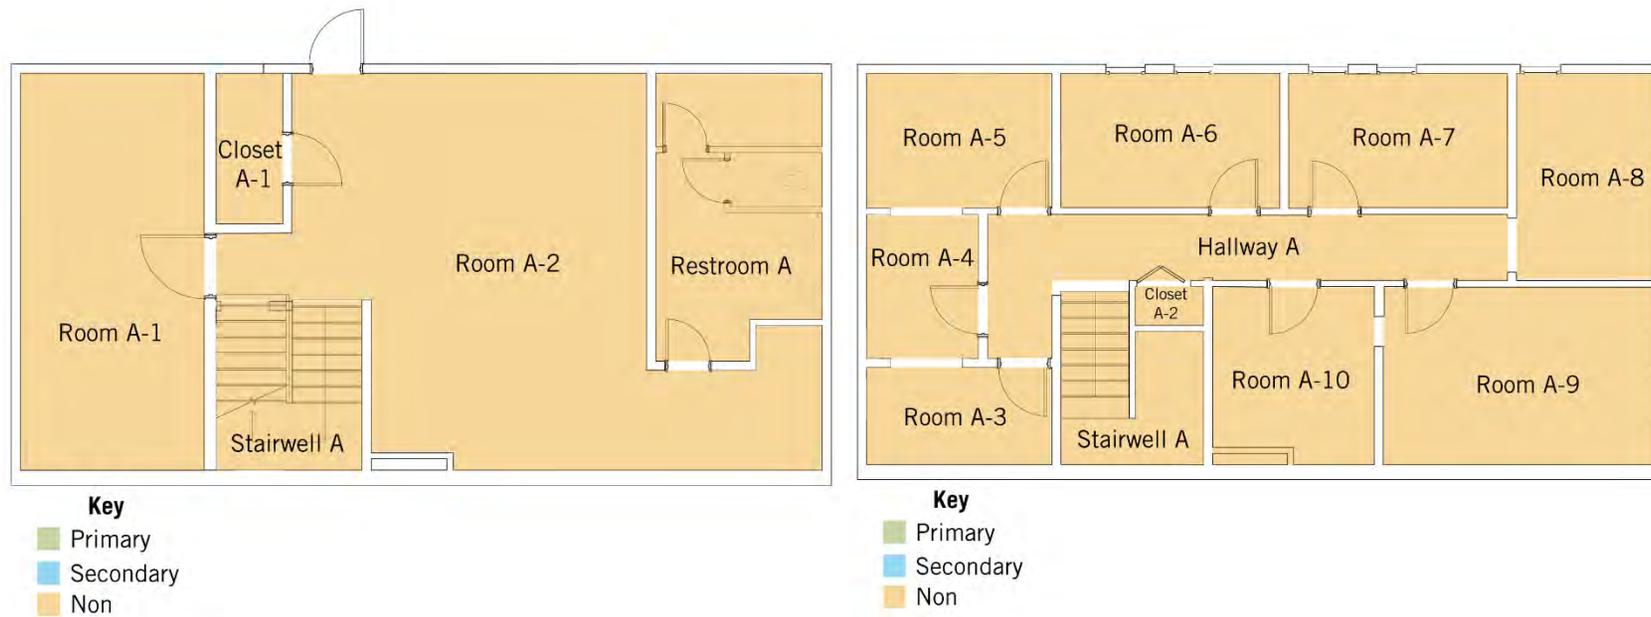
Figure 16 (LEFT): Non-character-defining spaces on the first floor of the 1980 addition. (ORW Architecture, annotated by GPA Consulting).

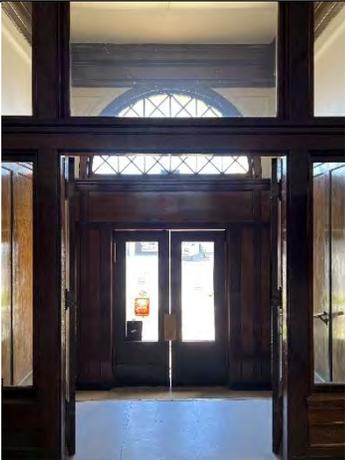
Feature	Photo (if applicable)	Importance: Reason	Condition/Alterations
<p>Space: Vestibule</p> <ul style="list-style-type: none"> • Accessed via Main Entry Door • Rectangular in plan • One story in height <p>Features:</p> <ul style="list-style-type: none"> • Fluorescent light fixture • Paired Interior Doors • Doorbell • Vestibule Stairs <p>Finishes:</p> <ul style="list-style-type: none"> • Flat ceiling • Inset paneling • Wood paneling, trim • Linoleum flooring

<p>Primary:</p> <ul style="list-style-type: none"> • Original • Highly visible • Minimally altered since the end of the period of significance • See individual features and finishes listed below. 	<p>Good.</p> <p>Alterations include installation of fluorescent light fixture and linoleum flooring.</p>

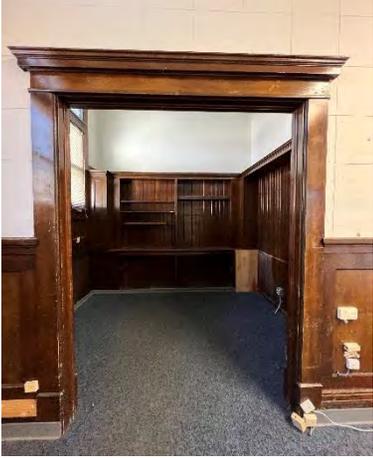
Feature	Photo (if applicable)	Importance: Reason	Condition/Alterations
<p>Space: Room 2</p> <ul style="list-style-type: none"> • Space appears to be original, but was utilized as File Room by Yreka Police Department • Accessed via archway off Open-Plan space <p>Features:</p> <ul style="list-style-type: none"> • Fluorescent light fixtures • Wood archway • Built-in bookshelf <p>Finishes:</p> <ul style="list-style-type: none"> • Coved ceiling • Plaster walls • Wood trim and wainscot • Carpet flooring

<p>Primary:</p> <ul style="list-style-type: none"> • Original • Highly visible • Minimally altered since the end of the period of significance • See individual features and finishes listed below. 	<p>Good.</p> <p>Alterations include installation of fluorescent light fixtures and carpeting.</p>

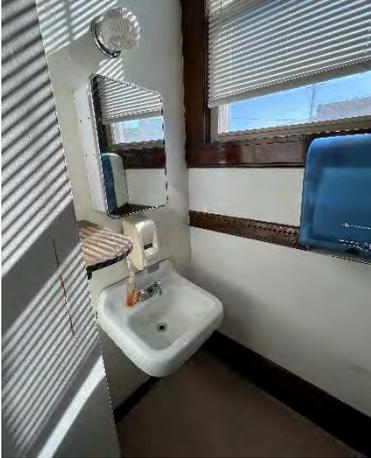
Feature	Photo (if applicable)	Importance: Reason	Condition/Alterations
<p>Space: Restrooms</p> <ul style="list-style-type: none"> • Space appears to be original, but was reconfigured as part of PD remodel • Accessed via doors on east side of Squad Room <p>Features:</p> <ul style="list-style-type: none"> • Fluorescent light fixtures • Globe lights • Wood interior doors • Porcelain Restroom Fixtures (sinks, toilets, urinal) • Soap/Paper Towel Dispensers • Mirror • Stall partitions <p>Finishes:</p> <ul style="list-style-type: none"> • Drop ceiling • Plaster/drywall partition walls • Wood trim • Linoleum Flooring

<p>Secondary:</p> <ul style="list-style-type: none"> • Utilitarian function/design • Less visible (e.g., private space) • Altered since the period of significance 	<p>Good.</p> <p>Space was reconfigured as part of Yreka PD renovation. Other alterations include installation of fluorescent lighting, linoleum flooring, and contemporary fixtures.</p>

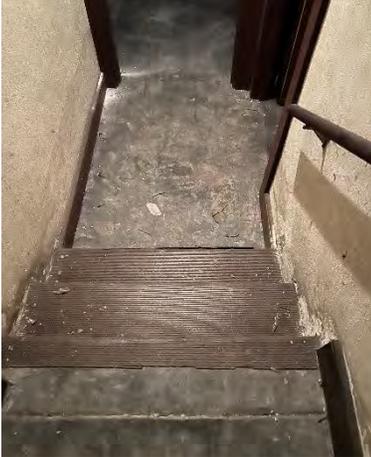
Feature	Photo (if applicable)	Importance: Reason	Condition/Alterations
<p>Space: Stairwell</p> <ul style="list-style-type: none"> • Accessed via stairs at northwest corner of Open-Plan space <p>Features:</p> <ul style="list-style-type: none"> • Contemporary light fixture • Wood interior door • Wood handrail • Wood stairs <p>Finishes:</p> <ul style="list-style-type: none"> • Unfinished ceiling • Cement plaster walls • Linoleum treads

<p>Not Character-Defining:</p> <ul style="list-style-type: none"> • Less visible • Utilitarian function/design • Common materials 	<p>Fair to Good.</p> <p>No major alterations observed.</p>
<p>Space: Room 5</p> <ul style="list-style-type: none"> • Research did not reveal the original use or configuration of the basement. • Accessed via stairs at northwest corner of Open-Plan space <p>Features:</p> <ul style="list-style-type: none"> • Fluorescent light fixtures • Hollow metal door <p>Finishes:</p> <ul style="list-style-type: none"> • Textured ceiling • Textured walls • Poured concrete floor • Linoleum tile floor

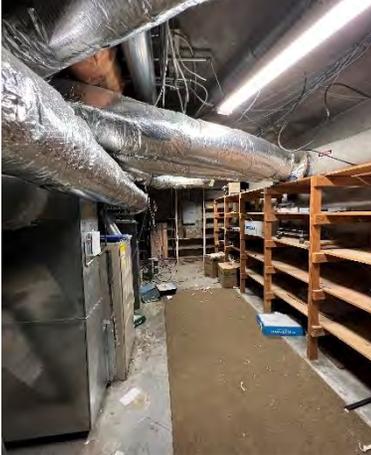
Feature	Photo (if applicable)	Importance: Reason	Condition/Alterations
<p>Space: Room 6</p> <ul style="list-style-type: none"> • Research did not reveal the original use or configuration of the basement. • Accessed via stairs at northwest corner of Open-Plan space <p>Features:</p> <ul style="list-style-type: none"> • Fluorescent light fixtures • Wood shelving • Wood interior doors • Hollow metal doors <p>Finishes:</p> <ul style="list-style-type: none"> • Unfinished ceiling • Concrete/textured walls • Poured concrete floor

<p>Not Character-Defining:</p> <ul style="list-style-type: none"> • Less visible • Utilitarian function/design • Common materials 	<p>Fair to Good.</p> <p>No major alterations observed.</p>

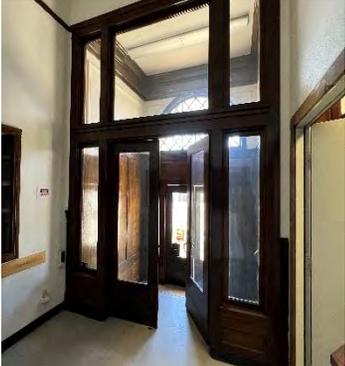
Table 4: Interior Features (Original Building)			
Feature	Photo (if applicable)	Importance: Reason	Condition/Alterations
Paired Interior Doors <ul style="list-style-type: none"> • Vestibule • Stained wood • Fully glazed • Sidelight and transom • Metal hardware

Primary: <ul style="list-style-type: none"> • Original • Highly visible • Minimally altered since the end of the period of significance 	Fair to Good. Stain is cracked/crazing, and worn at the base of the doors and sidelights. Scratches, gouges, and other signs of wear-and-tear observed. No major alterations observed.
Wood Columns <ul style="list-style-type: none"> • Open-Plan Space • Full height • Stained wood • Paneled

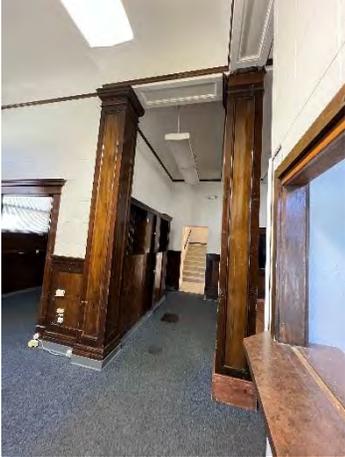
Primary: <ul style="list-style-type: none"> • Original • Highly visible • Minimally altered since the end of the period of significance 	Fair to Good. Scratches, gouges, and other signs of wear-and-tear observed. No major alterations observed.

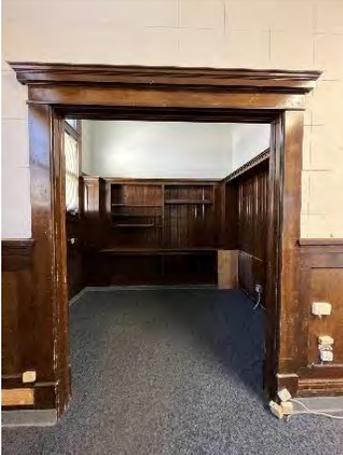
Table 4: Interior Features (Original Building)			
Feature	Photo (if applicable)	Importance: Reason	Condition/Alterations
<p>Wood Archway</p> <ul style="list-style-type: none"> • Between Open-Plan Space and Room 2 • Rectangular • Stained wood • Decorative header

<p>Primary:</p> <ul style="list-style-type: none"> • Original • Highly visible • Minimally altered since the end of the period of significance 	<p>Fair to Good. Scratches, gouges, and other signs of wear-and-tear observed.</p> <p>No major alterations observed.</p>
<p>Built-In Cabinets</p> <ul style="list-style-type: none"> • Open-Space Area • Stained wood • Decorative header • Partial-height cabinet doors

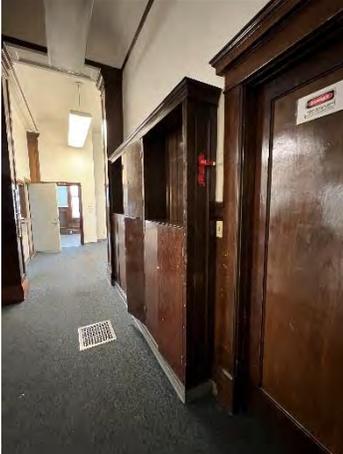
<p>Primary:</p> <ul style="list-style-type: none"> • Original • Highly visible • Directly related to historic Significance under A/C • Minimally altered since the end of the period of significance 	<p>Fair to Good. Scratches, gouges, and other signs of wear-and-tear observed.</p> <p>No major alterations observed.</p>

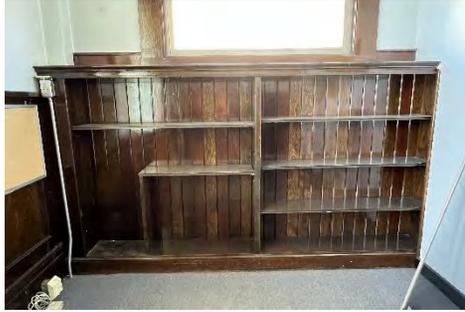
Feature	Photo (if applicable)	Importance: Reason	Condition/Alterations
<p>Built-In Bookcases</p> <ul style="list-style-type: none"> • Room 1, 2, and 4 • Partial height • Stained wood • Decorative molding along top edge

<p>Primary:</p> <ul style="list-style-type: none"> • Original • Highly visible • Directly related to historic Significance under A/C • Minimally altered since the end of the period of significance 	<p>Fair to Good. Stain is worn, leaving wood susceptible to deterioration. Scratches, gouges, and other signs of wear-and-tear observed.</p> <p>No major alterations observed.</p>
<p>Fireplace</p> <ul style="list-style-type: none"> • Open-Plan Space • Stained wood mantle with carved brackets • Tiled • Metal-framed glass fire screen

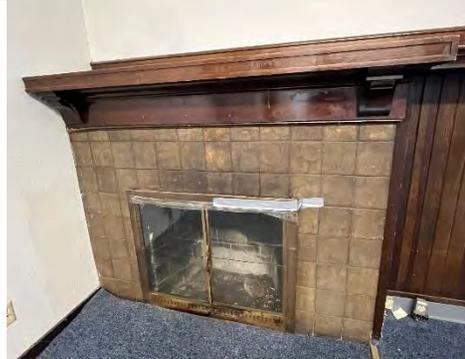
<p>Primary:</p> <ul style="list-style-type: none"> • Original • Highly visible • Minimally altered since the end of the period of significance 	<p>Fair to Good. White paint has been dripped onto the wood and tile. Fire-screen was secured with tape at the time of survey.</p> <p>Fire screen appears to be non-original.</p>

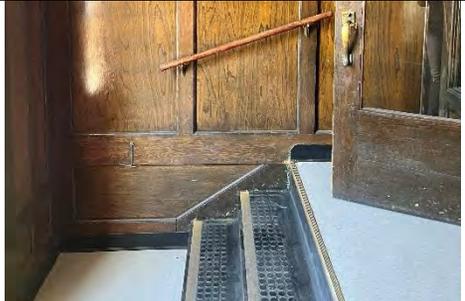
<p>Vestibule Stair</p> <ul style="list-style-type: none"> • Vestibule • Three stairs from Main Entry Door

<p>Primary:</p> <ul style="list-style-type: none"> • Original • Highly visible 	<p>Unknown. Stairs have been covered with non-original linoleum; historic fabric may be underneath.</p>

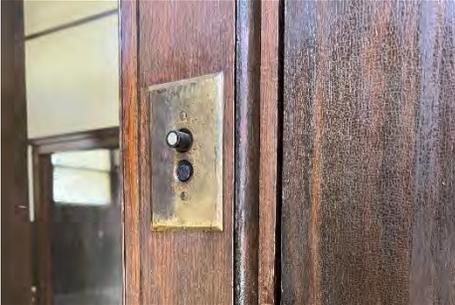
Feature	Photo (if applicable)	Importance: Reason	Condition/Alterations
Doorbell <ul style="list-style-type: none"> • Vestibule • Brass plate •

Secondary: <ul style="list-style-type: none"> • May date from the period of significance • Minor feature 	Fair to Good. Metal is tarnished. No major alterations observed.
Wood Handrails <ul style="list-style-type: none"> • Lobby • Stairwell • Round • Stained wood • Metal hardware

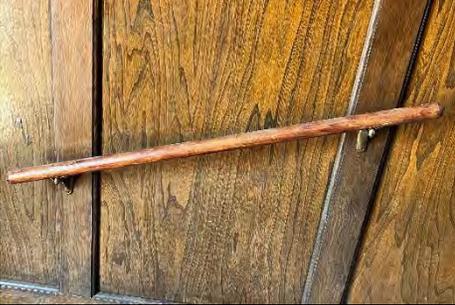
Secondary: <ul style="list-style-type: none"> • May date from the period of significance • Utilitarian function/design • Common material 	Good. No major alterations observed.
Fluorescent Lights <ul style="list-style-type: none"> • Vestibule • Lobby • Open-Plan Space • Rooms 1-6

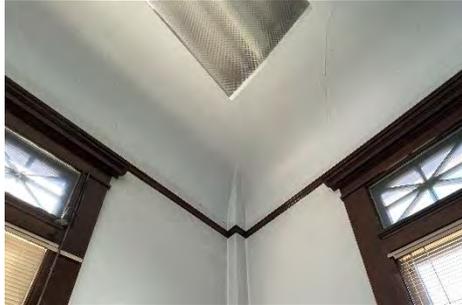
Table 5: Interior Finishes (Original Building)			
Feature	Photo (if applicable)	Importance: Reason	Condition/Alterations
Coved Ceiling <ul style="list-style-type: none"> • Open-Plan Space • Rooms 1-4 • Curved detail where wall meets the ceiling

Primary <ul style="list-style-type: none"> • Original • Highly visible • Minimally altered since the end of the period of significance 	Good. Ceiling profile disrupted in spaces with non-original partitions.
Barrel Ceiling <ul style="list-style-type: none"> • Lobby • Open-Plan Space • Multiple arched forms • Painted plaster • Stained or painted wood trim

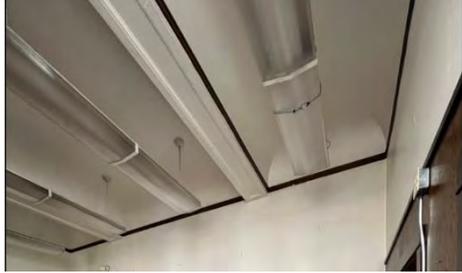
Primary <ul style="list-style-type: none"> • Original • Highly visible • Minimally altered since the end of the period of significance 	Good. Ceiling profile disrupted in spaces with non-original partitions.
Inset Paneling <ul style="list-style-type: none"> • Lobby • Painted plaster and wood trim

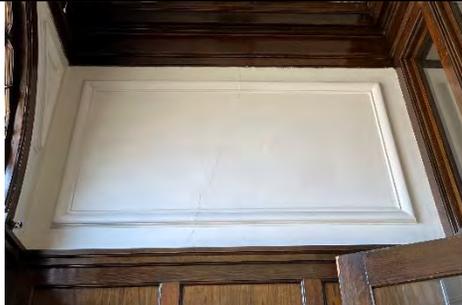
Primary <ul style="list-style-type: none"> • Original • Highly visible • Minimally altered since the end of the period of significance 	Fair to Good. Some surface cracking observed. No major alterations observed.

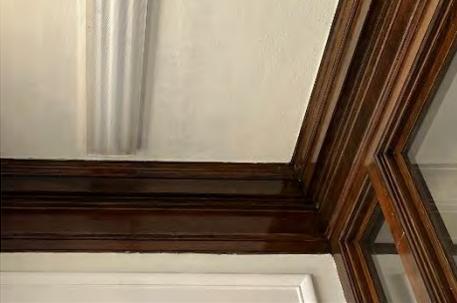
Feature	Photo (if applicable)	Importance: Reason	Condition/Alterations
<p>Crown Molding</p> <ul style="list-style-type: none"> • Lobby • Stained wood

<p>Primary</p> <ul style="list-style-type: none"> • Original • Highly visible • Minimally altered since the end of the period of significance 	<p>Good.</p> <p>No major alterations observed.</p>
<p>Picture Rail</p> <ul style="list-style-type: none"> • Open-Plan Space • Rooms 1, 3, 4 • Narrow trim along level of window headers • Stained wood

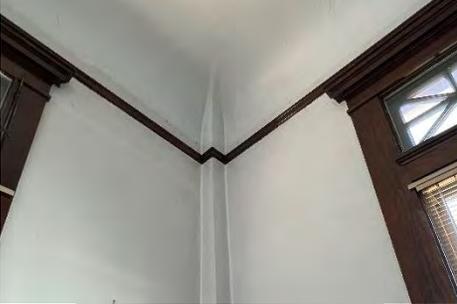
<p>Primary</p> <ul style="list-style-type: none"> • Original • Highly visible • Minimally altered since the end of the period of significance 	<p>Good.</p> <p>Trim disrupted in spaces with non-original partitions.</p>
<p>Wood Paneling</p> <ul style="list-style-type: none"> • Lobby • 3/4-height • Stained wood

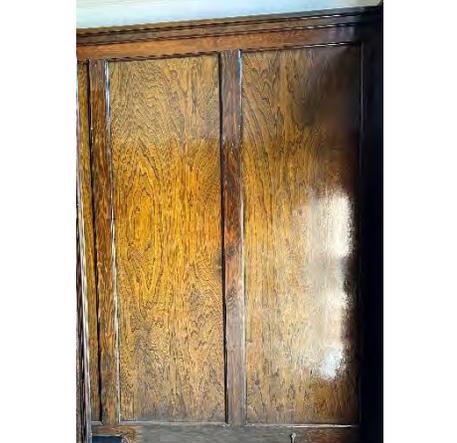
<p>Primary</p> <ul style="list-style-type: none"> • Original • Highly visible • Minimally altered since the end of the period of significance 	<p>Good.</p> <p>No major alterations observed.</p>

The rehabilitation of the main floor of the original building would include lead and asbestos abatement, upgrades to the existing restrooms, and removal of the non-original partition walls forming the Police Station Lobby. Other existing spaces would be converted to new office uses. Non-original features like florescent lighting, drop ceilings, and carpeting will be removed and replaced with a more historically compatible replacements or restored based on documentary evidence, if feasible. Original features like the wood trim and wood wall paneling and shelving would be retained and repaired as needed.

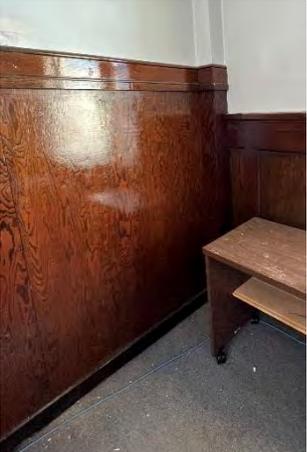
Feature	Photo (if applicable)	Importance: Reason	Condition/Alterations
<p>Wood Veneer</p> <ul style="list-style-type: none"> • Room 3 • 3/4-height • Stained wood

<p>Primary</p> <ul style="list-style-type: none"> • Original • Highly visible • Minimally altered since the end of the period of significance 	<p>Good.</p> <p>No major alterations observed.</p>
<p>Window Surrounds</p> <ul style="list-style-type: none"> • Open-Plan Space • Rooms 1-4

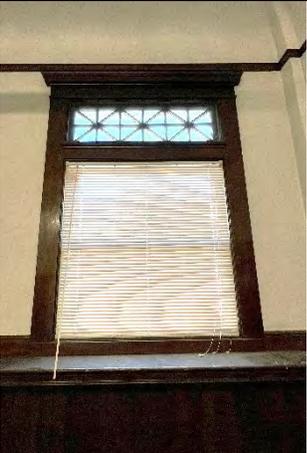
<p>Primary</p> <ul style="list-style-type: none"> • Original • Highly visible • Minimally altered since the end of the period of significance 	<p>Good.</p> <p>No major alterations observed.</p>

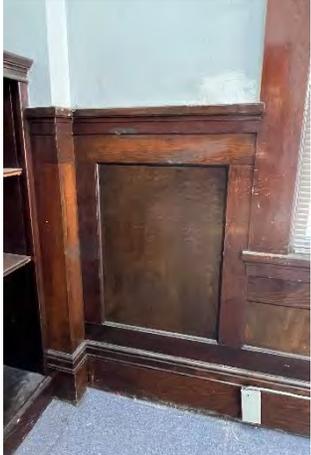
Feature	Photo (if applicable)	Importance: Reason	Condition/Alterations
<p>Wood Wainscot</p> <ul style="list-style-type: none"> • Open-Plan Space • Rooms 1-4 • 1/2 height • Stained wood

<p>Primary</p> <ul style="list-style-type: none"> • Original • Highly visible • Minimally altered since the end of the period of significance 	<p>Good.</p> <p>Disrupted in spaces with non-original partitions.</p>
<p>Base Molding</p> <ul style="list-style-type: none"> • Open-Plan Space • Rooms 1-4 • Restrooms

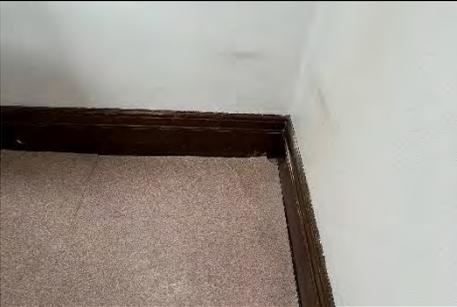
<p>Primary</p> <ul style="list-style-type: none"> • Original • Highly visible • Minimally altered since the end of the period of significance 	<p>Base molding is obscured by non-original rubber trim except for restroom. Condition not observed.</p>
<p>Flat Ceiling</p> <ul style="list-style-type: none"> • Lobby

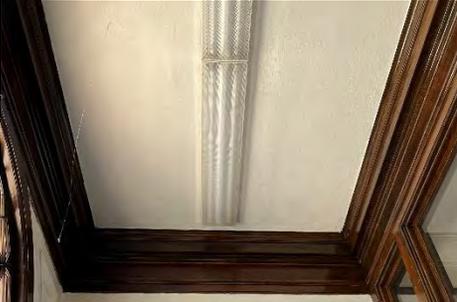
<p>Secondary</p> <ul style="list-style-type: none"> • May date from the period of significance • Utilitarian function/design • Common material 	<p>Good. Some minor surface cracking observed.</p> <p>No major alterations observed.</p>

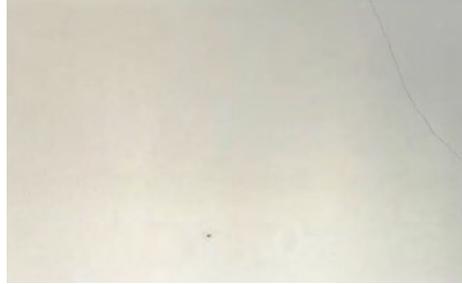
Feature	Photo (if applicable)	Importance: Reason	Condition/Alterations
Plaster Wall Finish <ul style="list-style-type: none"> • Wall finish along building perimeter and original partition walls presumed to be plaster • Open-Plan Space • Rooms 1-4 • Restrooms

Secondary <ul style="list-style-type: none"> • May date from the period of significance • Utilitarian function/design • Common material 	Fair to Good. Cracking observed. No major alterations observed.
Acoustic/Drop Ceiling <ul style="list-style-type: none"> • Restrooms

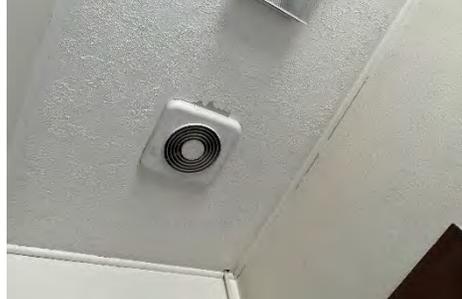
Not Character-Defining: <ul style="list-style-type: none"> • Postdates period of significance • Utilitarian function/design • Common material 	N/A
Textured Ceiling <ul style="list-style-type: none"> • Rooms 5-6

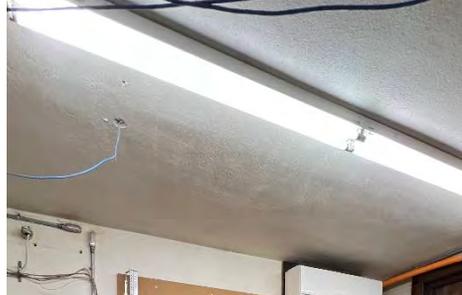
Not Character-Defining: <ul style="list-style-type: none"> • Appears to postdate period of significance Utilitarian function/design • Common material 	N/A

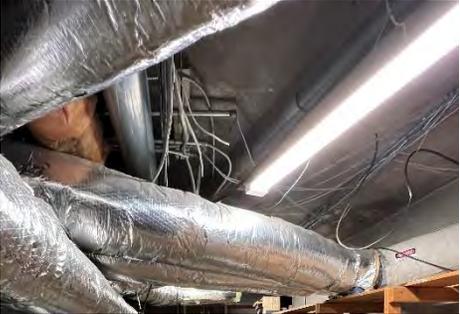
Feature	Photo (if applicable)	Importance: Reason	Condition/Alterations
Unfinished Ceiling <ul style="list-style-type: none"> • Room 6 • Stairwell

Not Character-Defining: <ul style="list-style-type: none"> • Utilitarian function/design • Common material 	N/A
Drywall – Smooth <ul style="list-style-type: none"> • Non-original partition walls presumed to be painted drywall • Open-Plan Space • Rooms 1-4 • Restrooms

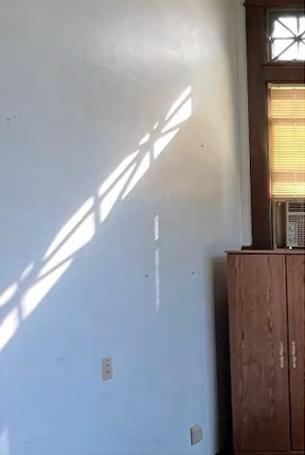
Not Character-Defining: <ul style="list-style-type: none"> • Postdates period of significance • Utilitarian function/design • Common material 	N/A
Drywall – Textured <ul style="list-style-type: none"> • Lobby • Open-Plan Space • Stairwell

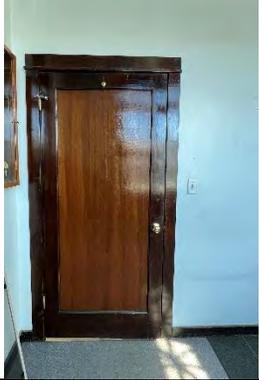
Feature	Photo (if applicable)	Importance: Reason	Condition/Alterations
<p>Wood Trim – Non-Original Partition Walls</p> <ul style="list-style-type: none"> • Baseboard • Door surrounds • Stained wood • Differentiated from original by simple, flat profile

<p>Not Character-Defining:</p> <ul style="list-style-type: none"> • Postdates period of significance • Common material 	<p>N/A</p>
<p>Linoleum Flooring</p> <ul style="list-style-type: none"> • Vestibule - Light Grey, Black • Lobby – Light Grey • Restrooms - Pink • Room 5 – Grey • Stairwell - Brown

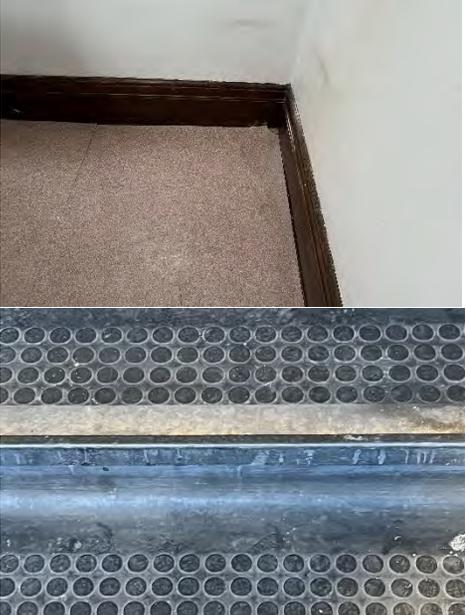
<p>Not Character-Defining:</p> <ul style="list-style-type: none"> • Postdates period of significance • Utilitarian function/design • Common material 	<p>N/A</p>

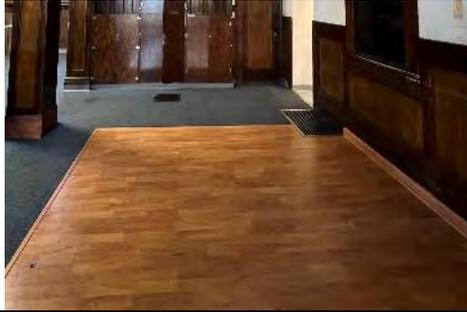
Not Character-Defining: <ul style="list-style-type: none"> • Postdates period of significance • Utilitarian function/design • Common material 	N/A
Laminate Flooring <ul style="list-style-type: none"> • Open-Plan Space

Not Character-Defining: <ul style="list-style-type: none"> • Postdates period of significance • Common material 	N/A
Poured Concrete Flooring <ul style="list-style-type: none"> • Rooms 5-6
