Yreka Carnegie Library

Historic Structure Report - DRAFT

Prepared by:
GPA Consulting
617 S. Olive Street
Suite 910
Los Angeles, CA 90014

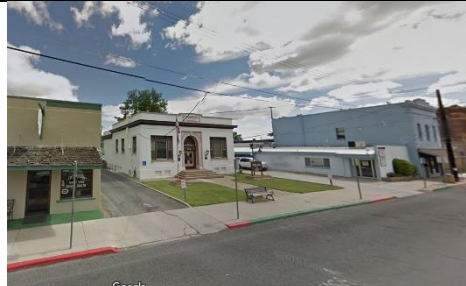
Primary: <ul style="list-style-type: none"> • Original • Highly visible • Minimally altered since the end of the period of significance 	Good. No alterations observed.

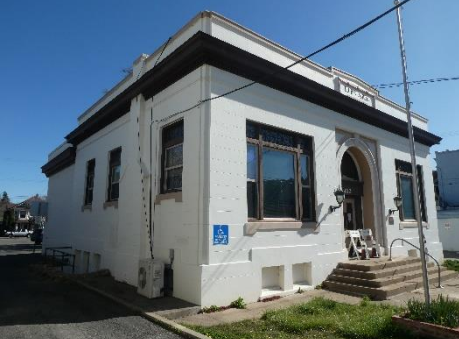
<p>Primary:</p> <ul style="list-style-type: none"> • Original • Highly visible • Directly related to historic significance under A/C • Minimally altered since the end of the period of significance 	<p>Good.</p> <p>Alterations include a rear two-story addition completed outside the period of significance.</p>
<p>Roof Form</p> <ul style="list-style-type: none"> • Flat with raised parapet

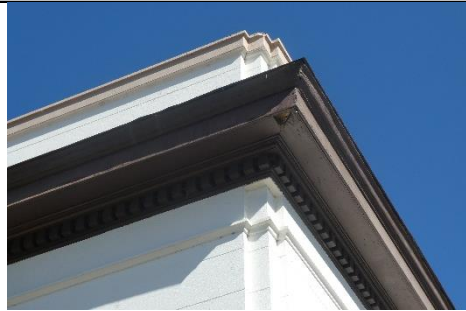
Primary: <ul style="list-style-type: none"> • Original • Highly visible • Directly related to historic significance under Criteria A/C • Minimally altered since the end of the period of significance 	Fair to Good. Water damage at corners of cornice observed No major alterations observed.
Cornice (Non-Original) <ul style="list-style-type: none"> • North, east, and west elevations of 1980 addition, • Painted wood • Dentil detail along bottom edge

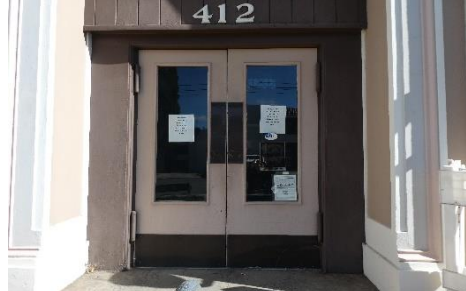
<p>Primary:</p> <ul style="list-style-type: none"> • Original • Highly visible • Minimally altered since the end of the period of significance 	<p>Good.</p> <p>Vertical wood siding appears to have been installed over transom at unknown date.</p>
<p>Main Entrance Door</p> <ul style="list-style-type: none"> • S1-D1 • South elevation • Painted wood • Paired • Fully glazed • Metal push and kickplates

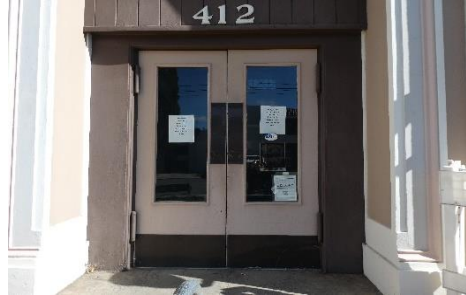
<p>Primary:</p> <ul style="list-style-type: none"> • Original • Highly visible • Replaced in kind at an unknown date 	<p>Fair to Good.</p> <p>Scratches, gouges, and other signs of wear-and-tear observed at inner edge of both doors.</p> <p>Doors appear to have been compatibly replaced at an unknown date.</p>

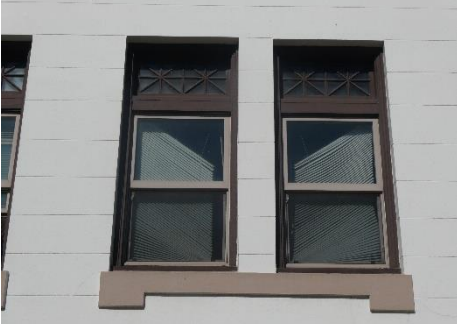
<p>Primary:</p> <ul style="list-style-type: none"> • Original • Highly visible <p>Minimally altered since the end of the period of significance</p>	<p>Good.</p> <p>Double-hung wood sashes appear to have been replaced in kind at an unknown date.</p>
<p>Single Double-Hung Windows</p> <ul style="list-style-type: none"> • W1-W1 through W1-W3 • West elevation • Painted wood frame, sash, muntins, and transom • One-over-one double-hung • Transom window with geometric muntins

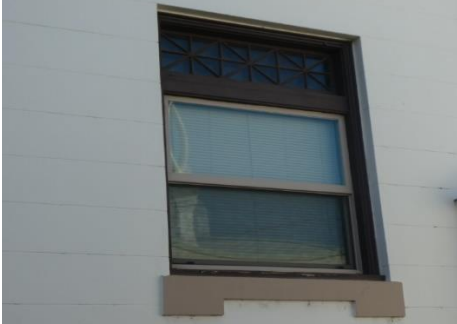
<p>Primary:</p> <ul style="list-style-type: none"> • Original • Highly visible <p>Minimally altered since the end of the period of significance</p>	<p>Good.</p> <p>Double-hung wood sashes appear to have been replaced in kind at an unknown date.</p>

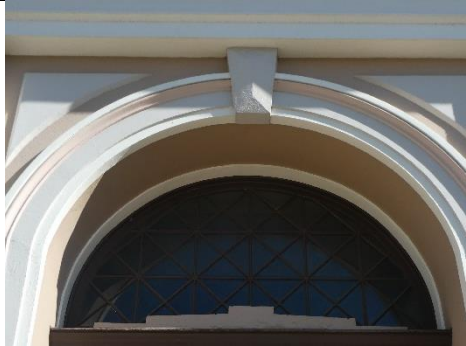
Not Character-Defining: <ul style="list-style-type: none"> • Less visible • Utilitarian in design/function • Altered since the end of the period of significance 	Fair. Glazing has been painted at an unknown date, metal security mesh installed over exterior of window openings at unknown date.
Cast Concrete <ul style="list-style-type: none"> • South, east, and west elevations of original building • Painted • Library Sign • Main entrance surround • Projecting window sills

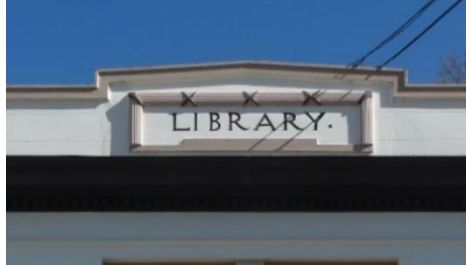
See individual features listed below.	See individual features below.
Library Sign <ul style="list-style-type: none"> • Center of south elevation parapet • Painted cast concrete • Incised letters Rectangular reed and ribbon frame

Primary: <ul style="list-style-type: none"> • Original • Highly visible • Directly related to historic significance under Criteria A/C • Minimally altered since the end of the period of significance 	Good. No alterations observed.

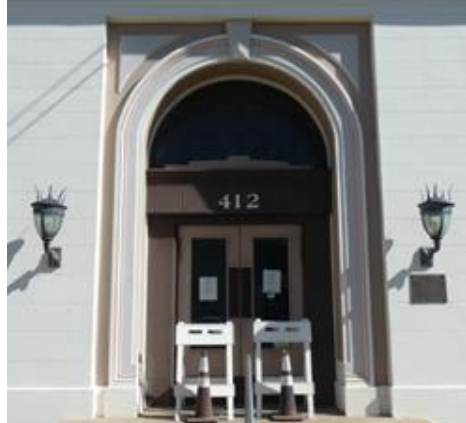
Feature	Photo (if applicable)	Importance: Reason	Condition/Alterations
<p>Main Entrance Surround</p> <ul style="list-style-type: none"> • South elevation • Painted cast concrete • Arched opening with keystone

<p>Primary:</p> <ul style="list-style-type: none"> • Original • Highly visible • Directly related to historic significance under Criteria A/C • Minimally altered since the end of the period of significance 	<p>Good.</p> <p>No major alterations observed.</p>
<p>Window Sills</p> <ul style="list-style-type: none"> • Under windows S1-W1, S1-W3, E1-W1 through E1-W-6, W1-W1 through W1-W3 • North, east, west elevation of original building • Painted cast concrete • Bracket-shaped

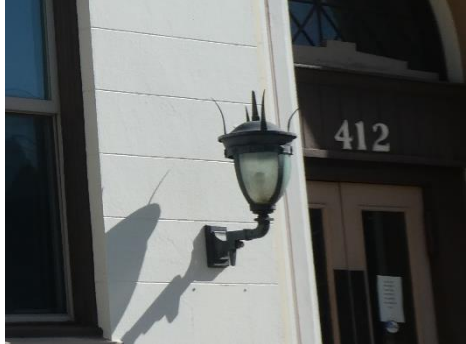
Feature	Photo (if applicable)	Importance: Reason	Condition/Alterations
<p>Light Fixtures</p> <ul style="list-style-type: none"> • South elevation • Painted metal • Lantern shape with decorative spikes • Mounted on arm/bracket

<p>Primary:</p> <ul style="list-style-type: none"> • Original • Highly visible • Minimally altered since the end of the period of significance 	<p>Good.</p> <p>No major alterations observed.</p>
<p>Front Yard Light</p> <ul style="list-style-type: none"> • South elevation • Painted metal • Fluted post with lantern on arm

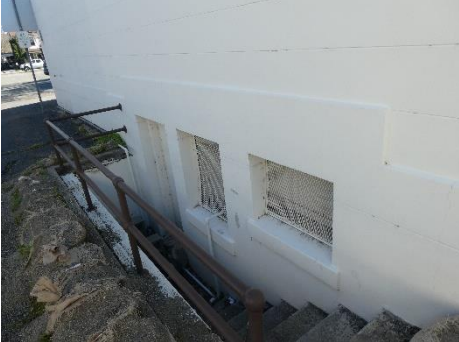
Feature	Photo (if applicable)	Importance: Reason	Condition/Alterations
Basement Door <ul style="list-style-type: none"> • WB-D1 • West elevation • Painted metal • Single door

Not Character-Defining <ul style="list-style-type: none"> • Partially visible • Utilitarian function/design Common material	Good. No alterations observed.
Basement Entry Stair Rail <ul style="list-style-type: none"> • West elevation • Painted Metal

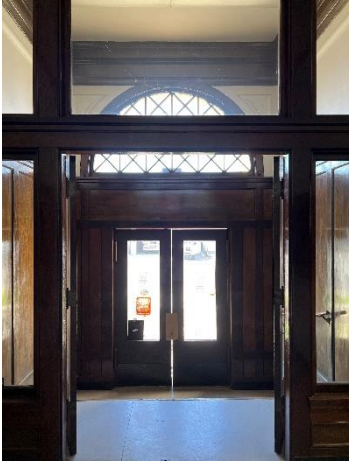
Feature	Photo (if applicable)	Importance: Reason	Condition/Alterations
<p>Space: Vestibule</p> <ul style="list-style-type: none"> • Accessed via Main Entry Door • Rectangular in plan • One story in height <p><u>Features:</u></p> <ul style="list-style-type: none"> • Fluorescent light fixture • Paired Interior Doors • Doorbell • Vestibule Stairs <p><u>Finishes:</u></p> <ul style="list-style-type: none"> • Flat ceiling • Inset paneling • Wood paneling, trim • Linoleum flooring

<p>Primary:</p> <ul style="list-style-type: none"> • Original • Highly visible • Minimally altered since the end of the period of significance • See individual features and finishes listed below. 	<p>Good.</p> <p>Alterations include installation of fluorescent light fixture and linoleum flooring.</p>

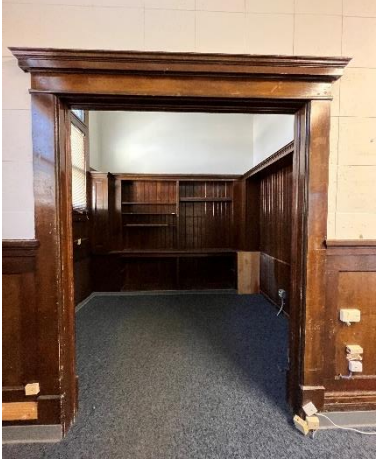
Feature	Photo (if applicable)	Importance: Reason	Condition/Alterations
<p>Space: Room 2</p> <ul style="list-style-type: none"> • Space appears to be original, but was utilized as File Room by Yreka Police Department • Accessed via archway off Open-Plan space <p>Features:</p> <ul style="list-style-type: none"> • Fluorescent light fixtures • Wood archway • Built-in bookshelf <p>Finishes:</p> <ul style="list-style-type: none"> • Coved ceiling • Plaster walls • Wood trim and wainscot • Carpet flooring

<p>Primary:</p> <ul style="list-style-type: none"> • Original • Highly visible • Minimally altered since the end of the period of significance • See individual features and finishes listed below. 	<p>Good.</p> <p>Alterations include installation of fluorescent light fixtures and carpeting.</p>

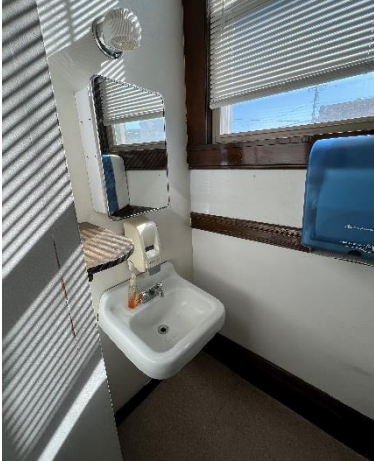
Feature	Photo (if applicable)	Importance: Reason	Condition/Alterations
<p>Space: Restrooms</p> <ul style="list-style-type: none"> • Space appears to be original, but was reconfigured as part of PD remodel • Accessed via doors on east side of Squad Room <p>Features:</p> <ul style="list-style-type: none"> • Fluorescent light fixtures • Globe lights • Wood interior doors • Porcelain Restroom Fixtures (sinks, toilets, urinal) • Soap/Paper Towel Dispensers • Mirror • Stall partitions <p>Finishes:</p> <ul style="list-style-type: none"> • Drop ceiling • Plaster/drywall partition walls • Wood trim • Linoleum Flooring

<p>Secondary:</p> <ul style="list-style-type: none"> • Utilitarian function/design • Less visible (e.g., private space) • Altered since the period of significance 	<p>Good.</p> <p>Space was reconfigured as part of Yreka PD renovation. Other alterations include installation of fluorescent lighting, linoleum flooring, and contemporary fixtures.</p>

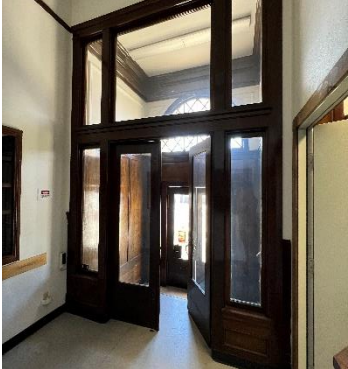
Feature	Photo (if applicable)	Importance: Reason	Condition/Alterations
<p>Paired Interior Doors</p> <ul style="list-style-type: none"> • Vestibule • Stained wood • Fully glazed • Sidelight and transom • Metal hardware

<p>Primary:</p> <ul style="list-style-type: none"> • Original • Highly visible • Minimally altered since the end of the period of significance 	<p>Fair to Good. Stain is cracked/crazing, and worn at the base of the doors and sidelights. Scratches, gouges, and other signs of wear-and-tear observed.</p> <p>No major alterations observed.</p>
<p>Wood Columns</p> <ul style="list-style-type: none"> • Open-Plan Space • Full height • Stained wood • Paneled

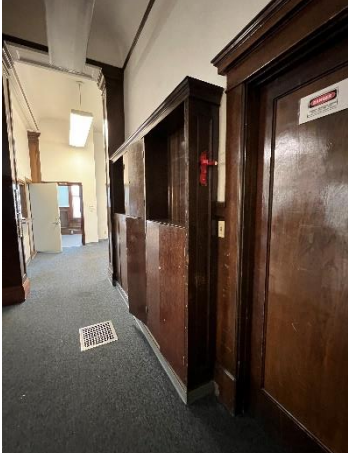
<p>Primary:</p> <ul style="list-style-type: none"> • Original • Highly visible • Directly related to historic Significance under A/C • Minimally altered since the end of the period of significance 	<p>Fair to Good. Scratches, gouges, and other signs of wear-and-tear observed.</p> <p>No major alterations observed.</p>

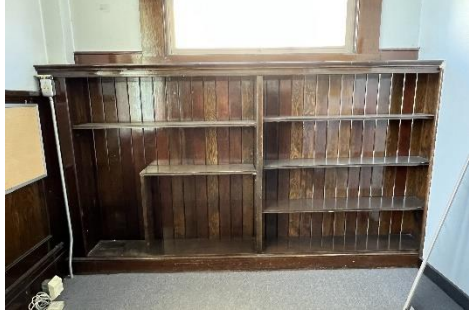
Feature	Photo (if applicable)	Importance: Reason	Condition/Alterations
<p>Built-In Bookcases</p> <ul style="list-style-type: none"> • Room 1, 2, and 4 • Partial height • Stained wood • Decorative molding along top edge

<p>Primary:</p> <ul style="list-style-type: none"> • Original • Highly visible • Directly related to historic Significance under A/C • Minimally altered since the end of the period of significance 	<p>Fair to Good. Stain is worn, leaving wood susceptible to deterioration. Scratches, gouges, and other signs of wear-and-tear observed.</p> <p>No major alterations observed.</p>
<p>Fireplace</p> <ul style="list-style-type: none"> • Open-Plan Space • Stained wood mantle with carved brackets • Tiled • Metal-framed glass fire screen

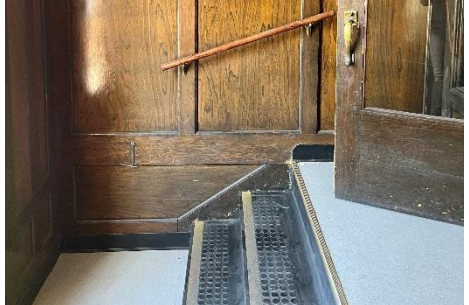
<p>Vestibule Stair</p> <ul style="list-style-type: none"> • Vestibule • Three stairs from Main Entry Door

<p>Primary:</p> <ul style="list-style-type: none"> • Original • Highly visible 	<p>Unknown. Stairs have been covered with non-original linoleum; historic fabric may be underneath.</p>

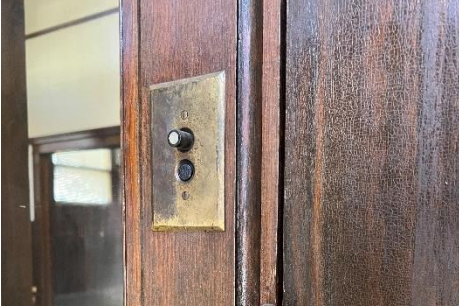
Feature	Photo (if applicable)	Importance: Reason	Condition/Alterations
Doorbell <ul style="list-style-type: none"> • Vestibule • Brass plate •

Secondary: <ul style="list-style-type: none"> • May date from the period of significance • Minor feature 	Fair to Good. Metal is tarnished. No major alterations observed.
Wood Handrails <ul style="list-style-type: none"> • Lobby • Stairwell • Round • Stained wood • Metal hardware

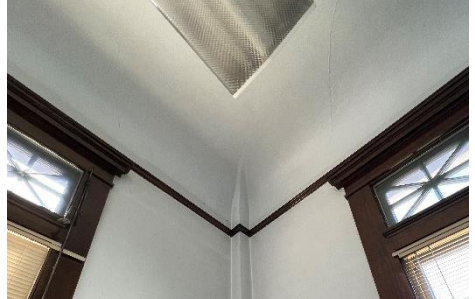
Feature	Photo (if applicable)	Importance: Reason	Condition/Alterations
Coved Ceiling <ul style="list-style-type: none"> • Open-Plan Space • Rooms 1-4 • Curved detail where wall meets the ceiling

Primary <ul style="list-style-type: none"> • Original • Highly visible • Minimally altered since the end of the period of significance 	Good. Ceiling profile disrupted in spaces with non-original partitions.
Barrel Ceiling <ul style="list-style-type: none"> • Lobby • Open-Plan Space • Multiple arched forms • Painted plaster • Stained or painted wood trim

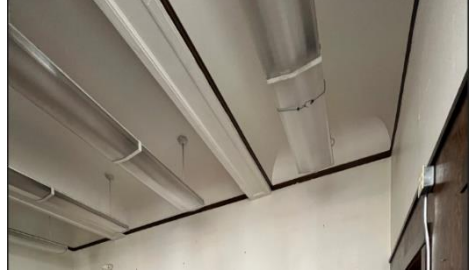
Primary <ul style="list-style-type: none"> • Original • Highly visible • Minimally altered since the end of the period of significance 	Good. Ceiling profile disrupted in spaces with non-original partitions.
Inset Paneling <ul style="list-style-type: none"> • Lobby • Painted plaster and wood trim

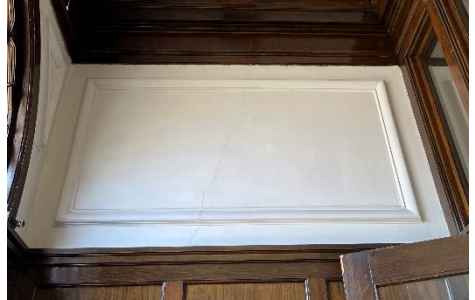
Primary <ul style="list-style-type: none"> • Original • Highly visible • Minimally altered since the end of the period of significance 	Fair to Good. Some surface cracking observed. No major alterations observed.

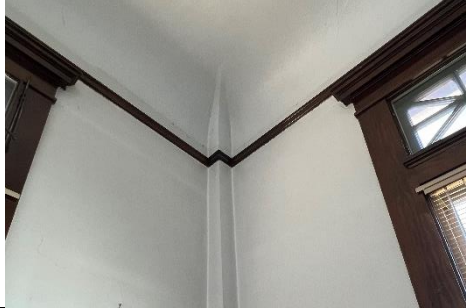
<p>Primary</p> <ul style="list-style-type: none"> • Original • Highly visible • Minimally altered since the end of the period of significance 	<p>Good.</p> <p>Trim disrupted in spaces with non-original partitions.</p>
<p>Wood Paneling</p> <ul style="list-style-type: none"> • Lobby • 3/4-height • Stained wood

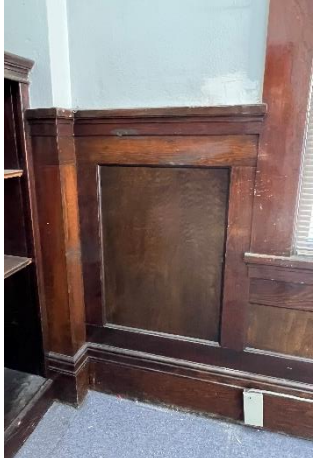
Feature	Photo (if applicable)	Importance: Reason	Condition/Alterations
<p>Wood Wainscot</p> <ul style="list-style-type: none"> • Open-Plan Space • Rooms 1-4 • 1/2 height • Stained wood

<p>Primary</p> <ul style="list-style-type: none"> • Original • Highly visible • Minimally altered since the end of the period of significance 	<p>Good.</p> <p>Disrupted in spaces with non-original partitions.</p>
<p>Base Molding</p> <ul style="list-style-type: none"> • Open-Plan Space • Rooms 1-4 • Restrooms

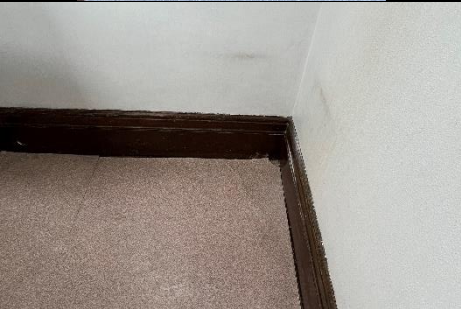
<p>Primary</p> <ul style="list-style-type: none"> • Original • Highly visible • Minimally altered since the end of the period of significance 	<p>Base molding is obscured by non-original rubber trim except for restroom. Condition not observed.</p>
<p>Flat Ceiling</p> <ul style="list-style-type: none"> • Lobby

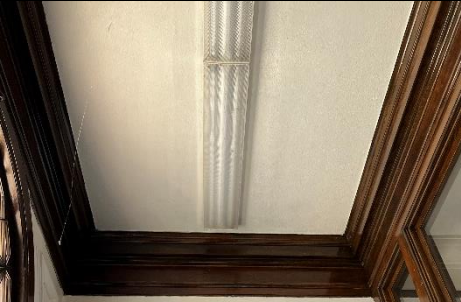
<p>Secondary</p> <ul style="list-style-type: none"> • May date from the period of significance • Utilitarian function/design • Common material 	<p>Good. Some minor surface cracking observed.</p> <p>No major alterations observed.</p>

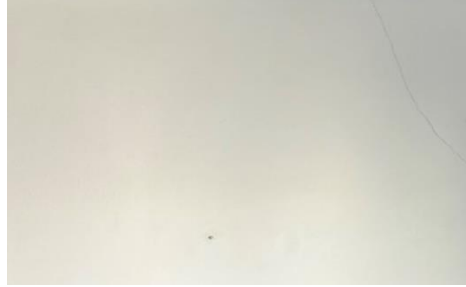
Feature	Photo (if applicable)	Importance: Reason	Condition/Alterations
Plaster Wall Finish <ul style="list-style-type: none"> • Wall finish along building perimeter and original partition walls presumed to be plaster • Open-Plan Space • Rooms 1-4 • Restrooms

Secondary <ul style="list-style-type: none"> • May date from the period of significance • Utilitarian function/design • Common material 	Fair to Good. Cracking observed. No major alterations observed.
Acoustic/Drop Ceiling <ul style="list-style-type: none"> • Restrooms

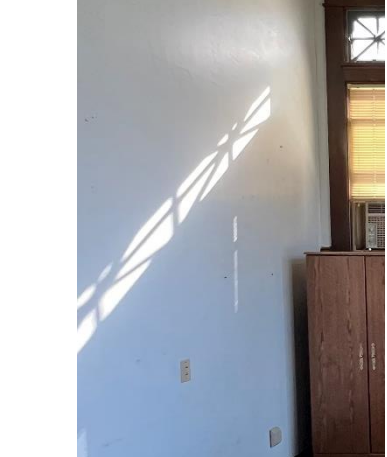
Not Character-Defining: <ul style="list-style-type: none"> • Postdates period of significance • Utilitarian function/design • Common material 	N/A
Drywall – Textured <ul style="list-style-type: none"> • Lobby • Open-Plan Space • Stairwell

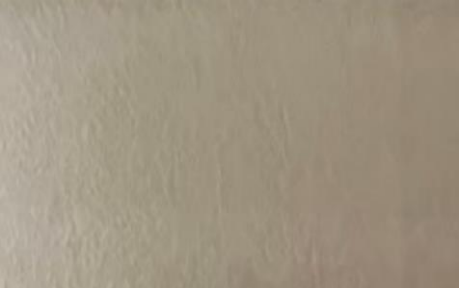
Not Character-Defining: <ul style="list-style-type: none"> • Postdates period of significance • Utilitarian function/design • Common material 	N/A

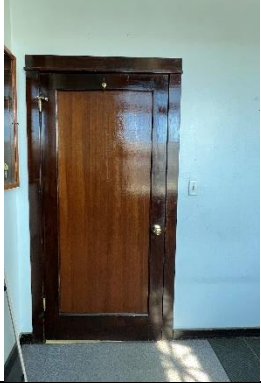
Feature	Photo (if applicable)	Importance: Reason	Condition/Alterations
<p>Wood Trim – Non-Original Partition Walls</p> <ul style="list-style-type: none"> • Baseboard • Door surrounds • Stained wood • Differentiated from original by simple, flat profile

<p>Not Character-Defining:</p> <ul style="list-style-type: none"> • Postdates period of significance • Common material 	<p>N/A</p>
<p>Linoleum Flooring</p> <ul style="list-style-type: none"> • Vestibule - Light Grey, Black • Lobby – Light Grey • Restrooms - Pink • Room 5 – Grey • Stairwell - Brown

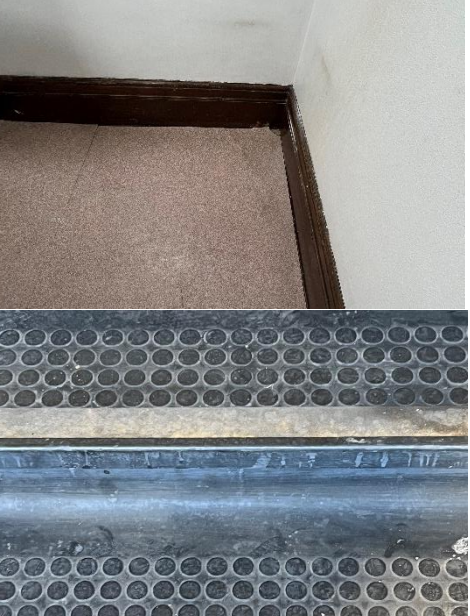
<p>Not Character-Defining:</p> <ul style="list-style-type: none"> • Postdates period of significance • Utilitarian function/design • Common material 	<p>N/A</p>

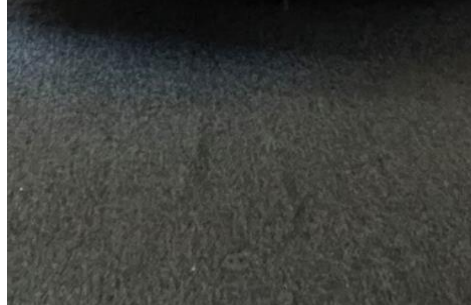
Feature	Photo (if applicable)	Importance: Reason	Condition/Alterations
Carpet Flooring <ul style="list-style-type: none"> • Open-Plan Space • Rooms 1-4

Not Character-Defining: <ul style="list-style-type: none"> • Postdates period of significance • Utilitarian function/design • Common material 	N/A
Laminate Flooring <ul style="list-style-type: none"> • Open-Plan Space

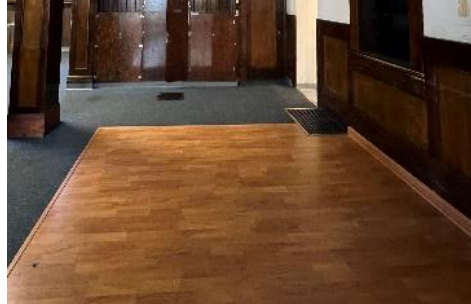
Not Character-Defining: <ul style="list-style-type: none"> • Postdates period of significance • Common material 	N/A
Poured Concrete Flooring <ul style="list-style-type: none"> • Rooms 5-6

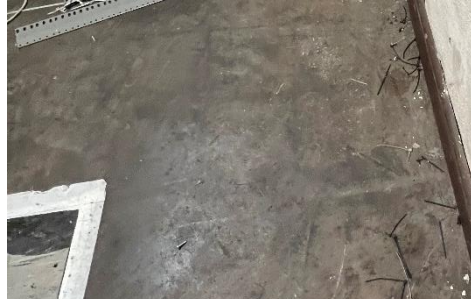
Not Character-Defining: <ul style="list-style-type: none"> • Utilitarian function/design • Common material 	N/A

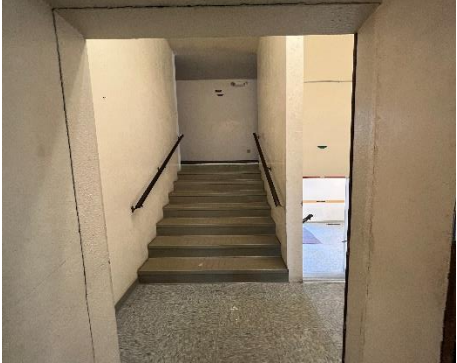
Feature	Photo (if applicable)	Importance: Reason	Condition/Alterations
<p>Stairwell A</p> <ul style="list-style-type: none"> • Accessed via north elevation of Original building • Leads to first and second floor of 1980 addition <p><u>Features</u></p> <ul style="list-style-type: none"> • Fluorescent light fixtures • Wood handrail <p><u>Finishes</u></p> <ul style="list-style-type: none"> • Flat ceiling • Drywall - Textured • Linoleum treads and risers

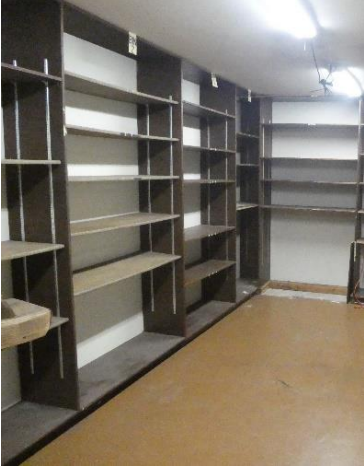
<p>Not Character-Defining</p> <ul style="list-style-type: none"> • Spaces, features, and finishes in 1980 addition postdate the period of significance 	<p>N/A</p>

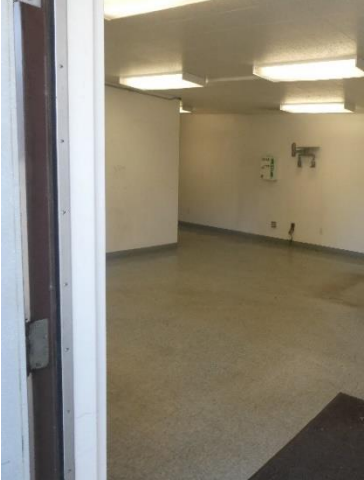
Feature	Photo (if applicable)	Importance: Reason	Condition/Alterations
<p>Space: Room A-2</p> <ul style="list-style-type: none"> • First floor, accessed via Rear Entrance and Stairwell A <p>Features:</p> <ul style="list-style-type: none"> • Fluorescent light fixtures • Metal counter with sink and stove • Wood cabinets <p>Finishes:</p> <ul style="list-style-type: none"> • Acoustic/drop ceiling • Drywall – Textured • Linoleum floors

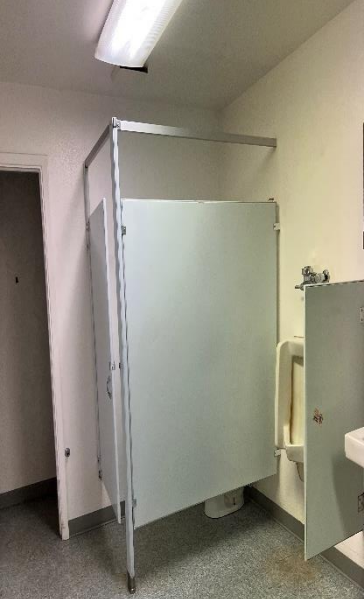
<p>Not Character-Defining</p> <ul style="list-style-type: none"> • Spaces, features, and finishes in 1980 addition postdate the period of significance 	<p>N/A</p>

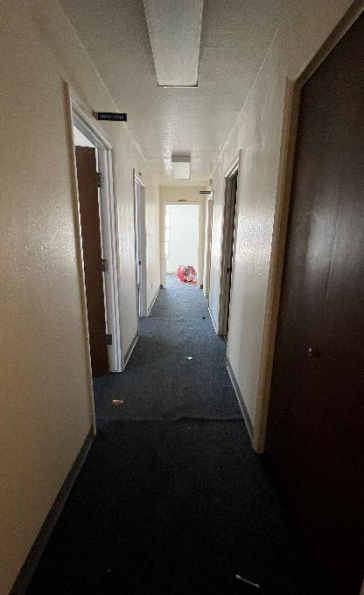
Feature	Photo (if applicable)	Importance: Reason	Condition/Alterations
<p>Hallway A</p> <ul style="list-style-type: none"> • Second floor, accessed off Stairwell A <p><u>Features:</u></p> <ul style="list-style-type: none"> • Fluorescent light fixtures • Wood interior doors <p><u>Finishes:</u></p> <ul style="list-style-type: none"> • Acoustic/drop ceiling • Drywall • Linoleum baseboard • Carpet flooring

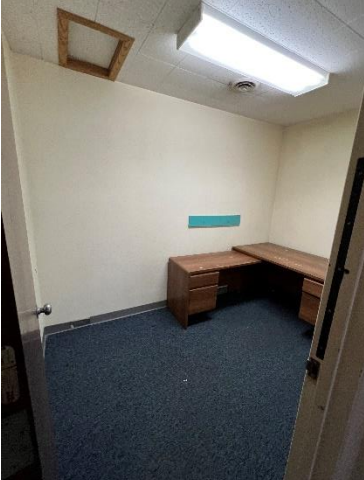
<p>Not Character-Defining</p> <ul style="list-style-type: none"> • Spaces, features, and finishes in 1980 addition postdate the period of significance 	<p>N/A</p>

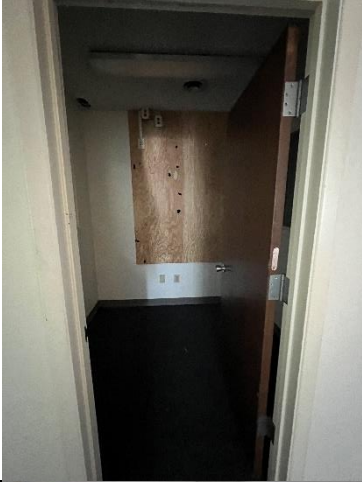
Table 6: Interior Spaces, Features, and Finishes (Addition)			
Feature	Photo (if applicable)	Importance: Reason	Condition/Alterations
<p>Space: Room A-4</p> <ul style="list-style-type: none"> • Second floor, accessed via door at west end of Hallway A <p>Features:</p> <ul style="list-style-type: none"> • Fluorescent light fixtures • Wood interior door • Transparent mirror <p>Finishes:</p> <ul style="list-style-type: none"> • Acoustic/drop ceiling • Drywall • Linoleum baseboard • Carpet flooring

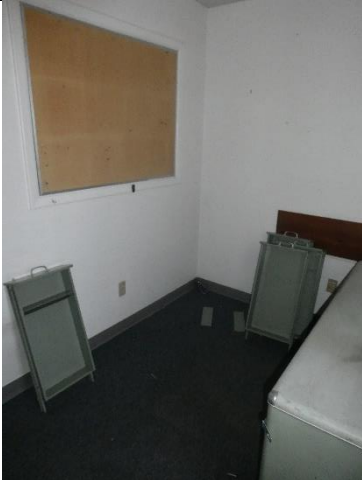
<p>Not Character-Defining</p> <ul style="list-style-type: none"> • Spaces, features, and finishes in 1980 addition postdate the period of significance 	N/A

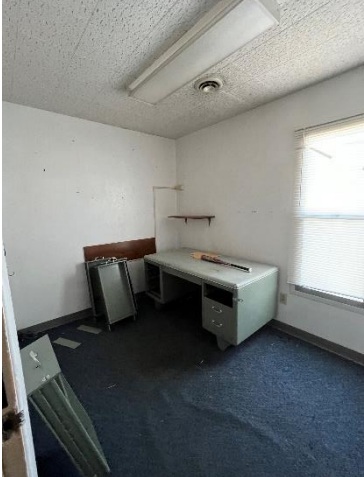
Feature	Photo (if applicable)	Importance: Reason	Condition/Alterations
<p>Space: Room A-6</p> <ul style="list-style-type: none"> • Second floor, accessed via door on north side of Hallway A <p><u>Features:</u></p> <ul style="list-style-type: none"> • Fluorescent light fixtures • Wood interior door • Window shades <p><u>Finishes:</u></p> <ul style="list-style-type: none"> • Acoustic/drop ceiling • Drywall • Linoleum baseboard • Carpet flooring

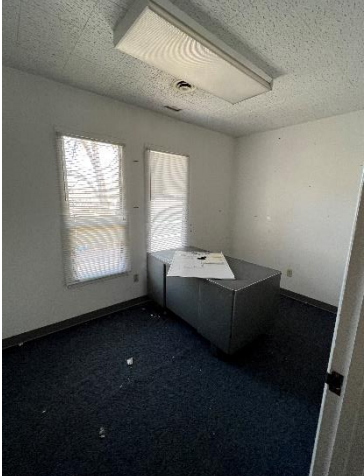
<p>Not Character-Defining</p> <ul style="list-style-type: none"> • Spaces, features, and finishes in 1980 addition postdate the period of significance 	<p>N/A</p>

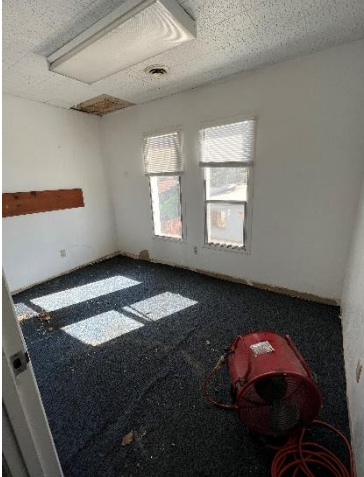
Feature	Photo (if applicable)	Importance: Reason	Condition/Alterations
<p>Space: Room A-8</p> <ul style="list-style-type: none"> • Second floor, accessed via door at east end of Hallway A <p>Features:</p> <ul style="list-style-type: none"> • Fluorescent light fixtures • Wood interior door • Window shades <p>Finishes:</p> <ul style="list-style-type: none"> • Acoustic/drop ceiling • Drywall • Linoleum baseboard • Carpet flooring

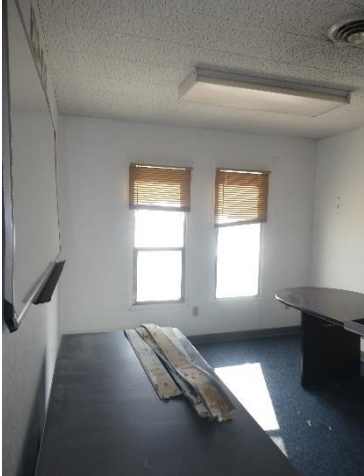
<p>Not Character-Defining</p> <ul style="list-style-type: none"> • Spaces, features, and finishes in 1980 addition postdate the period of significance 	<p>N/A</p>

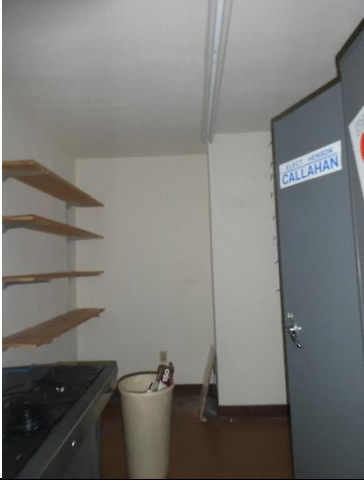
Feature	Photo (if applicable)	Importance: Reason	Condition/Alterations
<p>Space: Room A-10</p> <ul style="list-style-type: none"> • Second floor, accessed via door on south side of Hallway A <p>Features:</p> <ul style="list-style-type: none"> • Fluorescent light fixtures • Wood interior door <p>Finishes:</p> <ul style="list-style-type: none"> • Flat ceiling • Drywall • Linoleum baseboard • Linoleum flooring
